# Signature Inspection Services

## CONFIDENTIAL INSPECTION REPORT

**Sample New Construction Home Inspection**

Sample, Ovideo, FL 32765

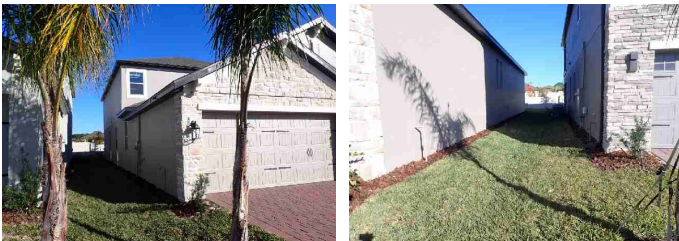
Drainage at both the east and west sides of this home appears less than ideal. Although the elevation of the home is such that water intrusion to within the living space is currently not a concern, grade is such that water likely ponds at both sides of the home. Recommend monitor drainage during our typical rainy season and adjust grade as needed to get moisture off and away from the structure efficiently. The homes are close in proximity to one another which makes drainage concerns all that more important.

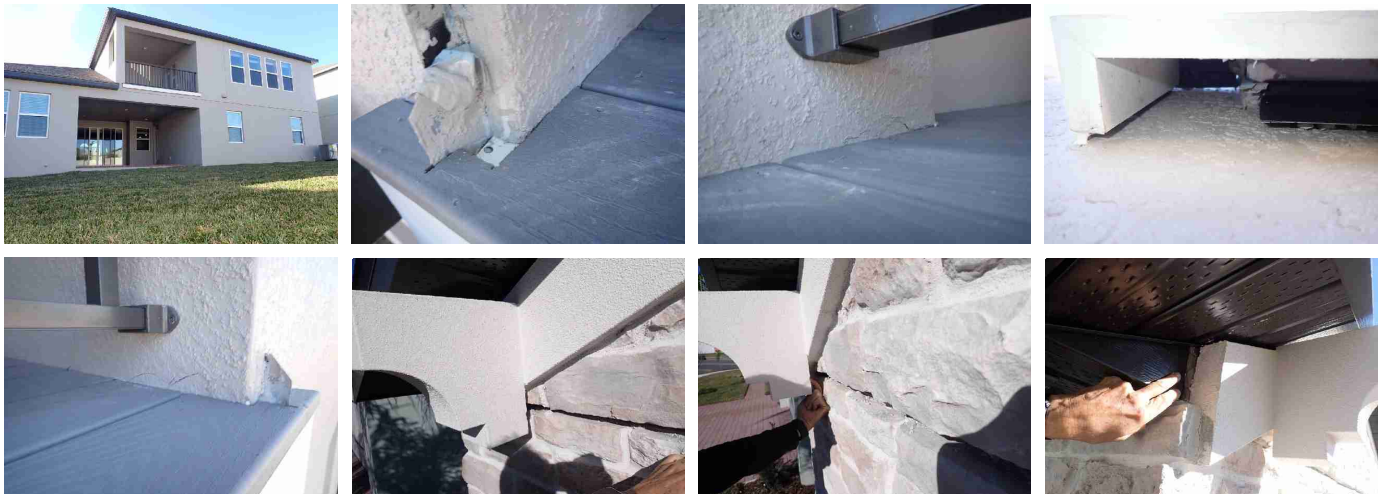
1. The stucco and flashing at rear balcony leading edge (both sides) is gapped and damaged. This is a vulnerable area by design and will need further review and service as needed to prevent moisture intrusion to with the substrate causing damage.
2. Decorative Stucco Foam Trim added features to the exterior envelope are subject to impacted and/or UV damage if not properly maintained. Front gable attached foam pieces are not fully stucco/painted/sealed on all sides and band trim at front door is most susceptible to impact damage. Fully review all foam accents and paint/seal as needed.

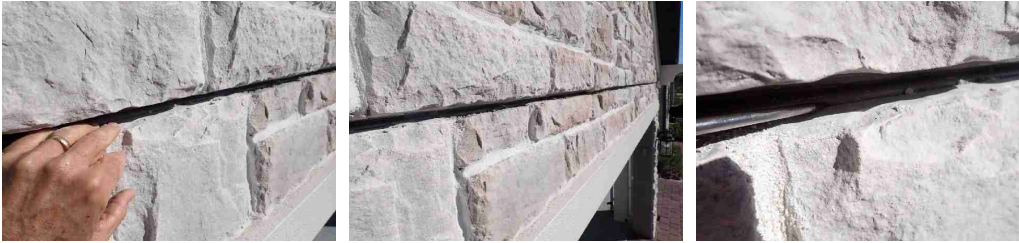
Faux stone applied to substrate is not fully sealed and connection at block to gable expansion joint - Seal as needed to meet designed performance standards.

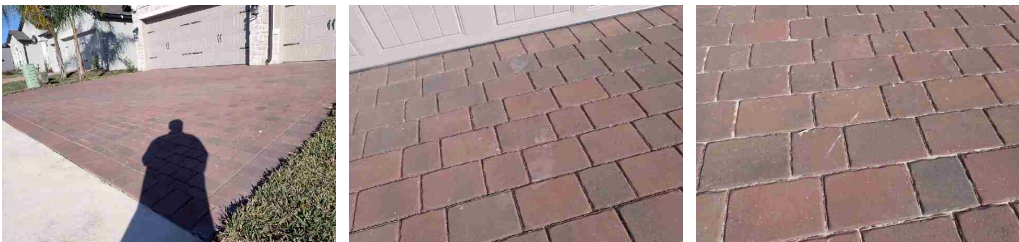
The driveway is in acceptable condition. Recommend clean construction scuffs and stains to be complete.

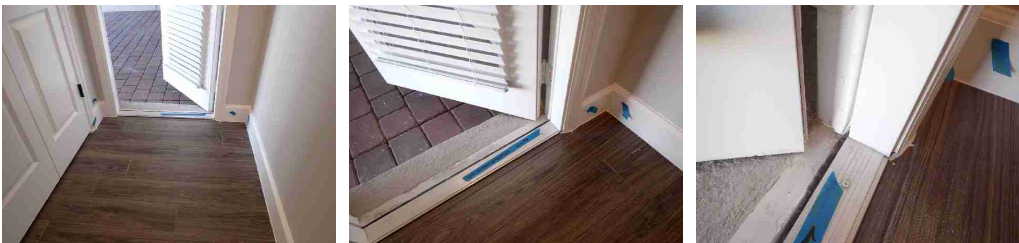
- The pool bath door needs minor service:
1. Adjust gapped weather stripping at south side base
  2. Seal/caulk door frame verticals to door metal sill
  3. Clean and clear construction debris to be complete

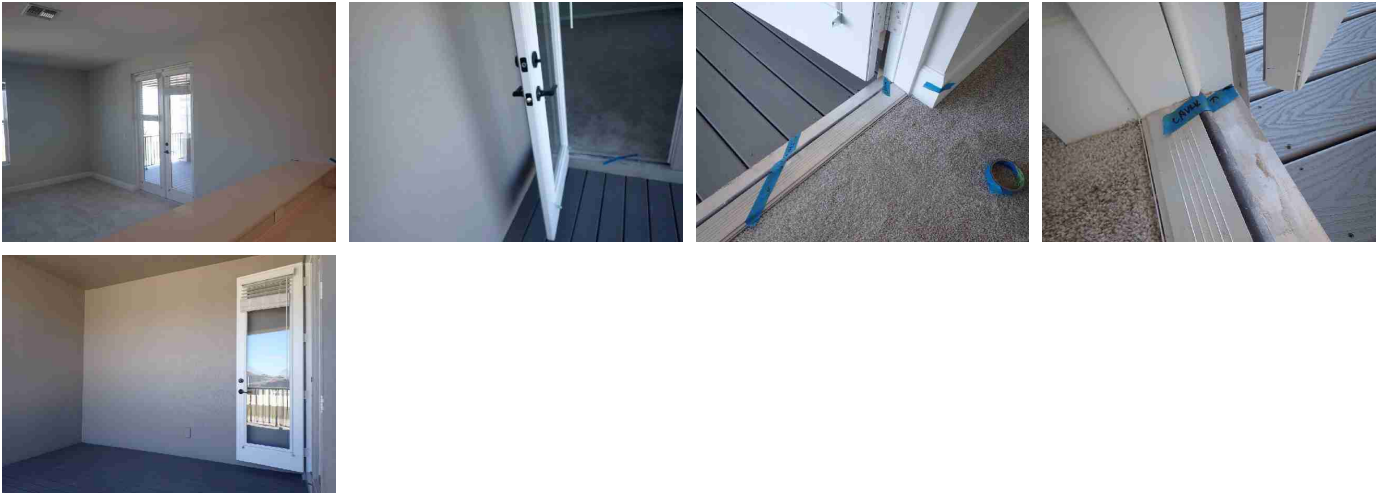
- Up balcony door:
1. Seal gaps as noted in image
  2. Clean the door sill system of construction debris
  3. Recommend add door stop to protect doors from damaging exterior stucco siding

Up balcony door needs minor service - *Continued*

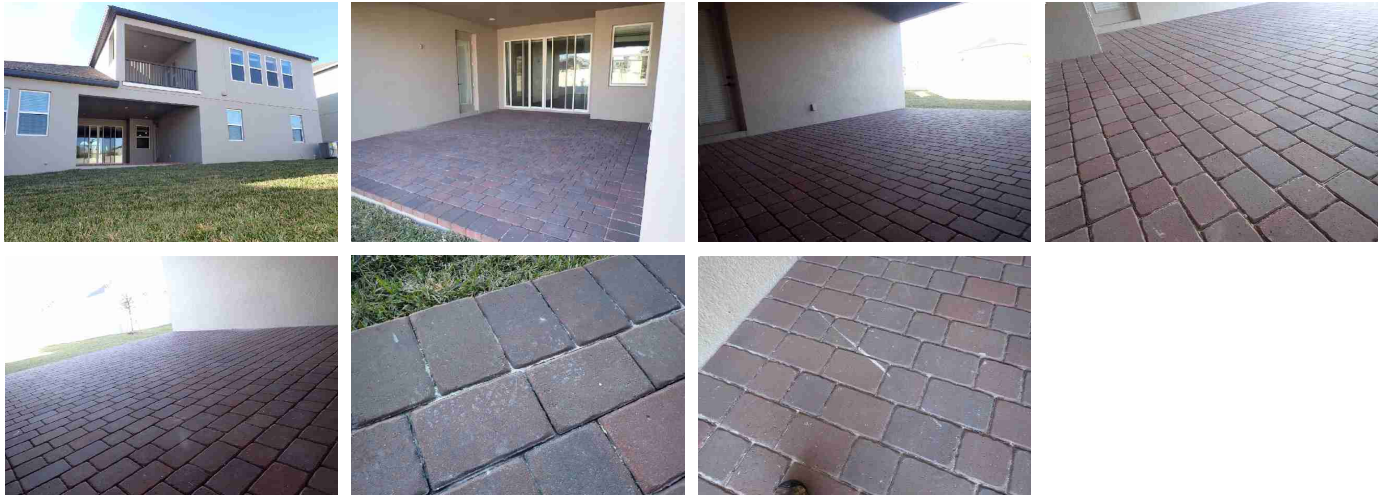
The rear inset porch appears to be in acceptable condition however there is minor construction debris and staining that will need service to make this area complete - Service as needed.

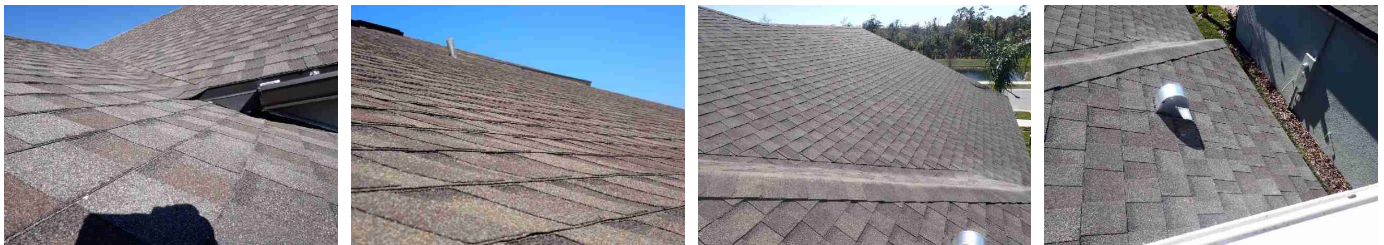
There are minor roof maintenance items that should be serviced. See below for reference. Periodic roof maintenance/review by a licensed roofing contractor is recommended.

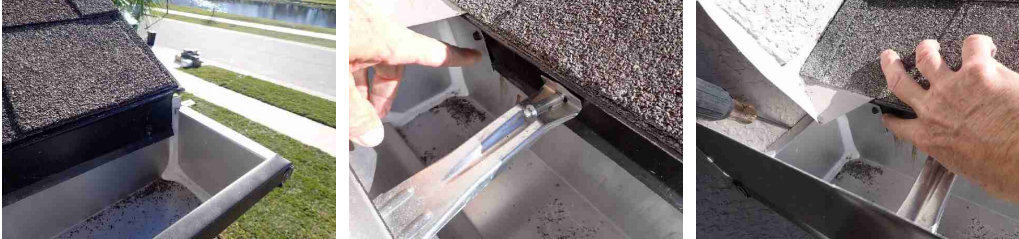
The gutters appear to be in acceptable condition. However:

1. Gutter tuck cuts at the drip edge are recommended to be sealed to protect water from entering behind the fascia wrap.

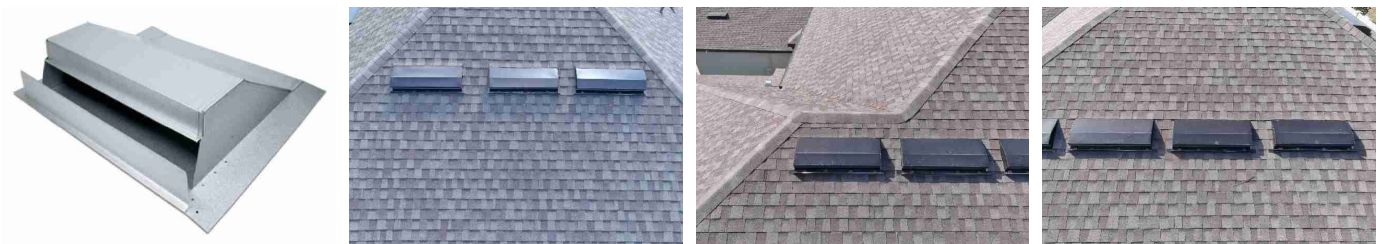
The leading edge of this off ridge vents are gapped and/or face nailed which, in a wind driven rain condition will allow moisture to within he attic and subsequently the living space. Seal/secure as needed.

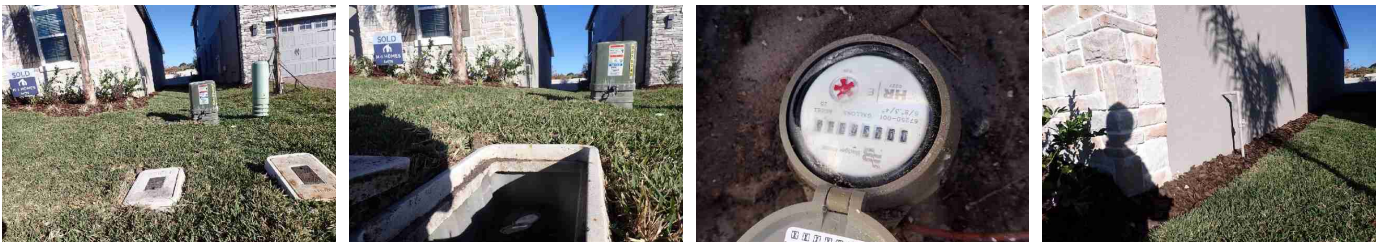
NOTE: The shutoff at the right side of the home is subject to UV and bump damage - Recommend insulate and add a bump guard to protect from damage

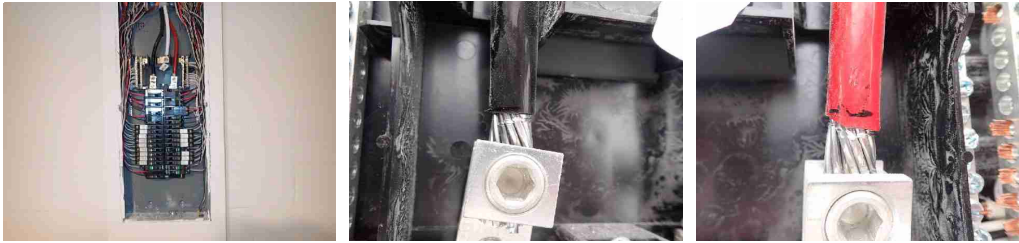
Individual wires of the aluminum strand service conductors that supply power to this sub panel in the garage are cut thus reducing the capacity and increasing resistance of the cable to carry current. A licensed electrician should be summoned to review and service this issue.

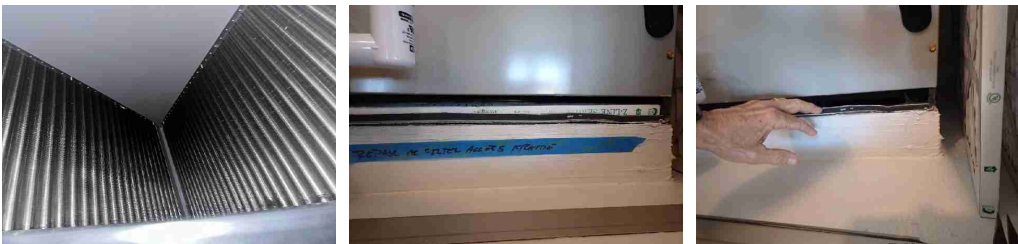
The evaporator coil is clean and functional. However the filter access frame is damaged restricting the ability to easily check and change filters. Recommend repair/adjust frame opening and better seal the AH base frame to the return plenum.

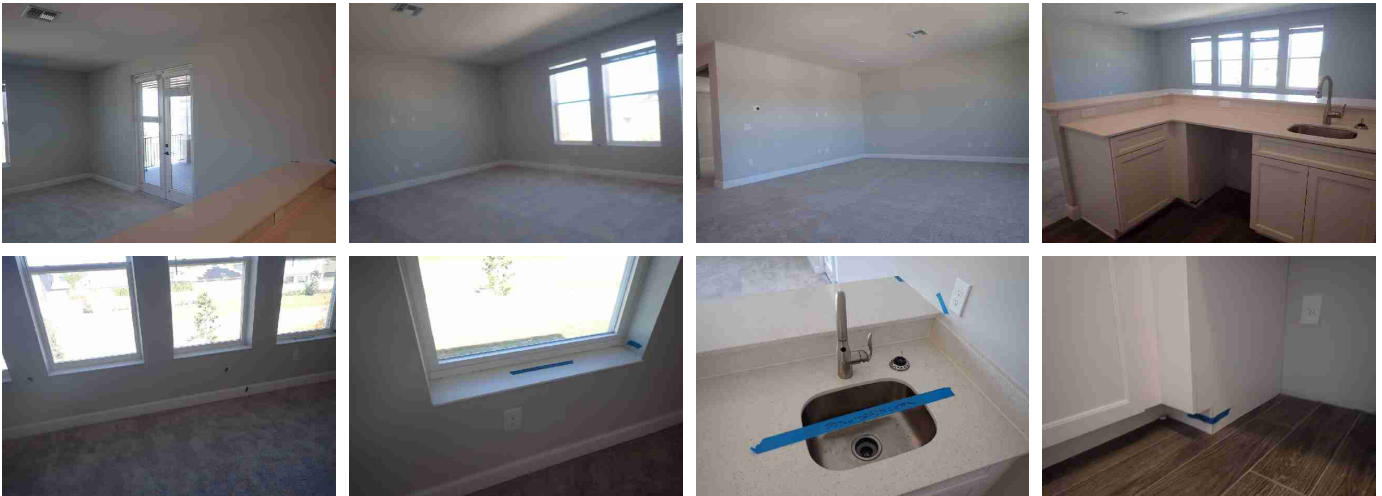
1. Walls and ceilings need paint touch up as identified with blue tape.
2. The window frame is gapped at the sill connection, most noted at the right window.
3. This up bonus room includes a bar sink area.
  - a. The bar sink trap leaks - recommend plumber service as needed. Water was dried to reduce risk of damage and sink was labeled as an active leak
  - b. The cabinet toe kick left of the beverage cooler opening is not fully secured to the cabinet base - Service as needed.
  - c. The outlet for the beverage cooler (not present) is not a dedicated outlet as is common practice - See building plans for protocol in this case/municipality..

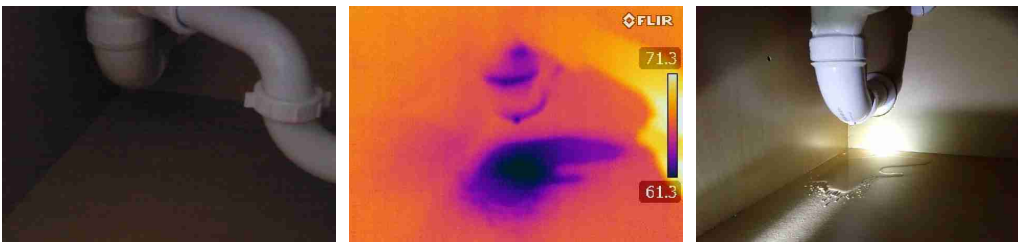
Visual and IR image of sink drain pipe leak upon discovery prior to drying with a towel.

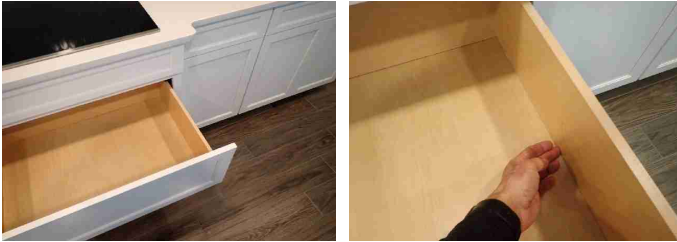
The floor of the cabinet drawer under cooktop is not secure in the dado cut of the cabinet. Adding weight such as pots and pans is likely to damage the drawer - Recommend review current condition and service as needed.

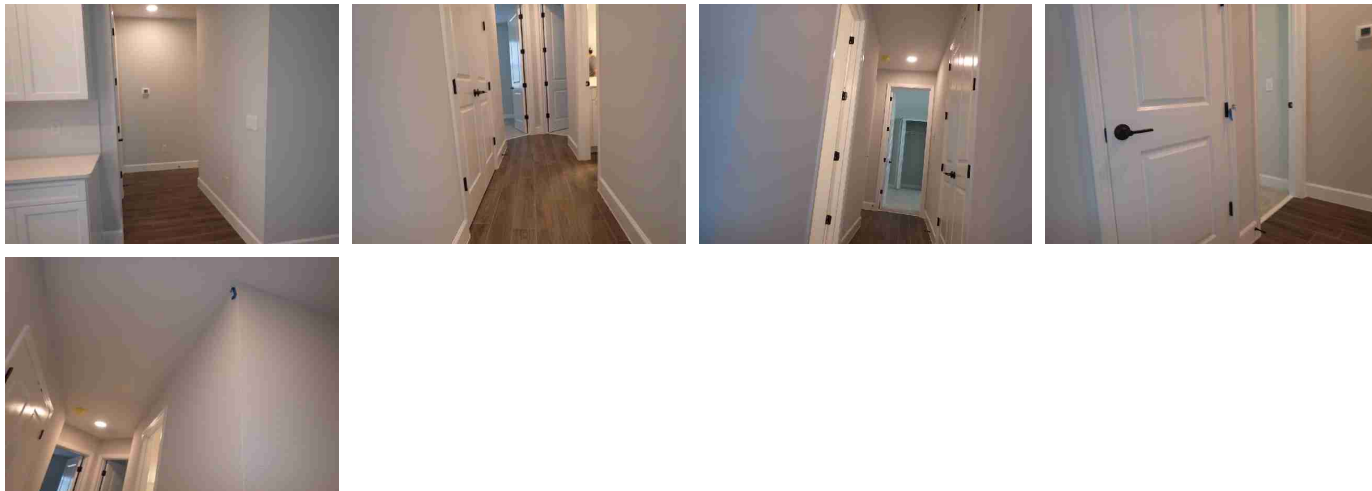
We have evaluated the hallway, and found it to be in acceptable condition and this area includes an operational 3-way hallway light system. However paint touch-up is needed as identified with blue tape - Service as needed.

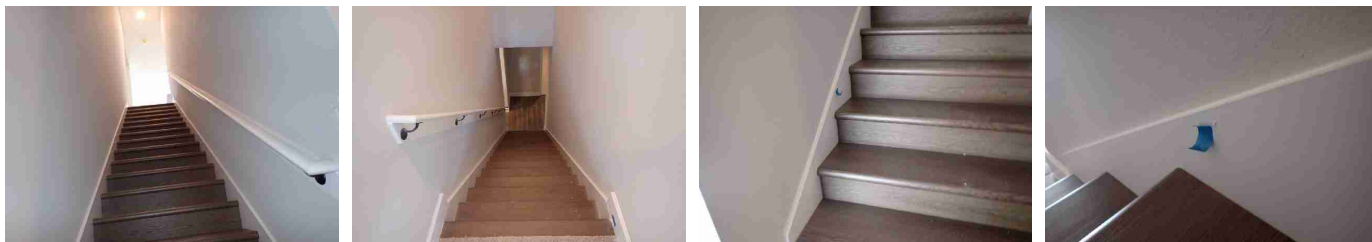
1. The left skirt trim has a fastener not fully seated - See area identified with blue tape - Service as needed.
2. Skirt trim at top landing left side is incomplete. Service this area as needed and review opposing right side for similar conditions - Both areas need service to be considered complete and to common professional standards
3. Hand railing needs minor refinishing to smooth rough surfaces.

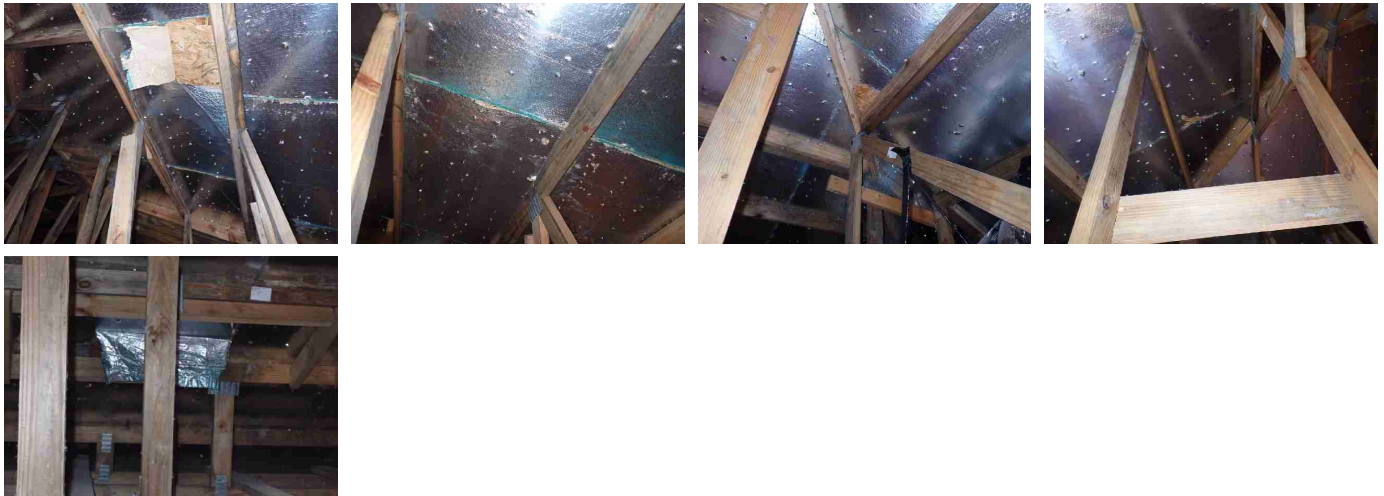
Foil backed OSB roof decking is damaged in areas - Recommend full review of both attic areas and service/repair damaged foil areas for full design benefit of this radiant barrier. see photos of examples

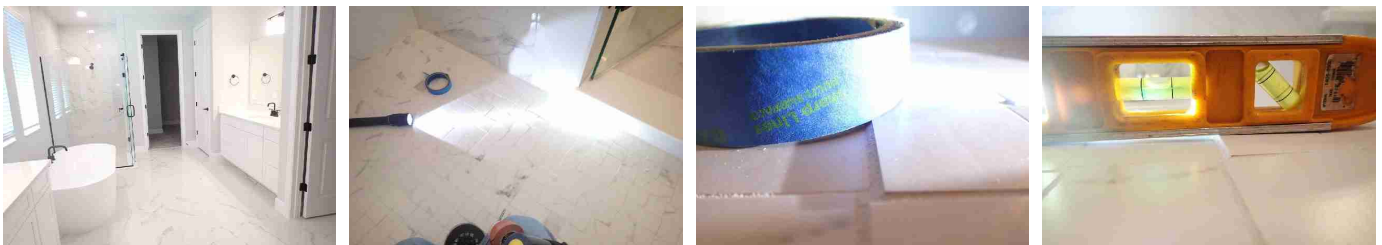
The stall shower is functional. However there is floor tile offset in the field and at the drain area. The concern is that in bare feet the sharp edges of the tile can act as a mandolin slicer filleting the bottom of a shower user foot. Recommend tile professional review tile installation and service as needed to meet common industry standards and minimize this apparent risk

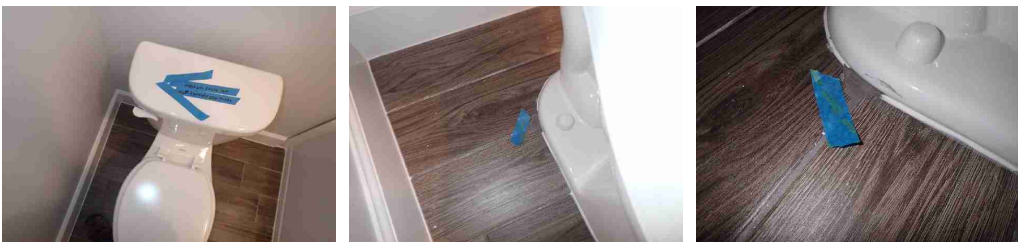
NOTE: There is tile chipped at the toilet connection to the floor and then filled with grout. Replacement or service of this tile is not recommended however you may wish to discuss this noted condition with you builder during the new homeowner orientation.
