CONFIDENTIAL INSPECTION REPORT

Sample Townhome Inspection Report

Sample, Winter Garden, FL 34787

9/3/2024 9:00 am to 12:30 pm

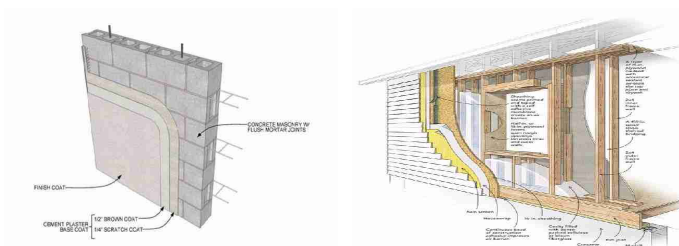
The house walls are finished with stucco and cementitious clapboard siding.

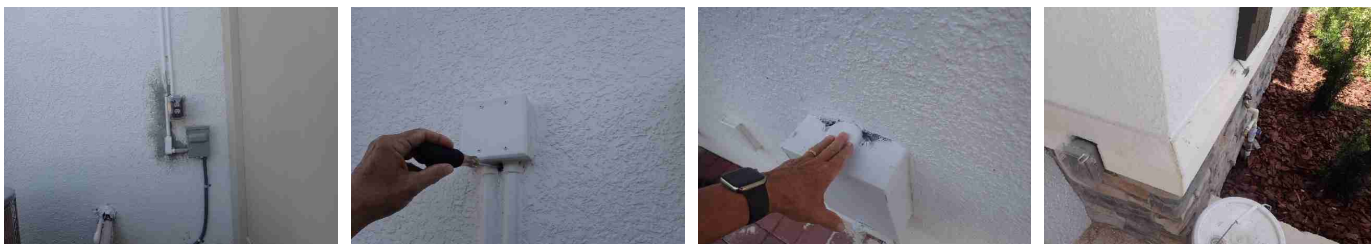
The house wall finish appears serviceable however there are a number of gaps and minor cracks in the paint surfaces with areas of thin paint coverage. It is recommended to seal all non-intended wall surface holes or gaps and/or stucco cracks, horizontal ledges, as each is a potential leak source. Paint is the first and best line of defense against moisture intrusion. s this is a new installation the work is considered incomplete. Caulk seal paint the home and maintain sealant in an effort to forestall moisture intrusion.

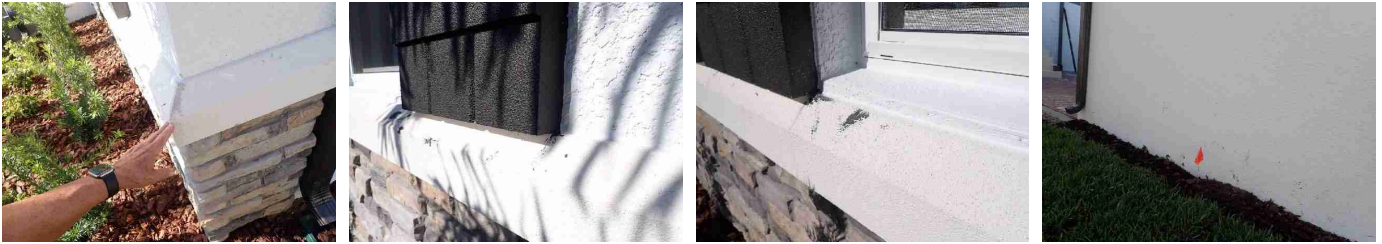
The house wall finish appears serviceable however - *Continued*

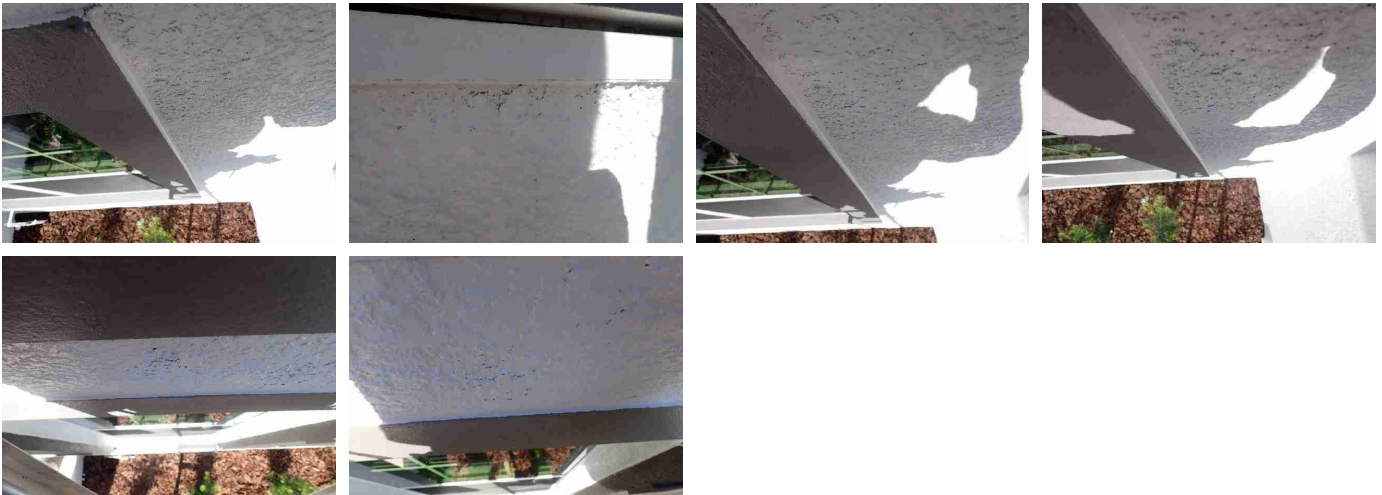
At higher elevations on the sides of the home the irregular stucco finish in areas is missing full and complete paint coverage. Often homes are sprayed and from below the paint sprays up into the crevices but the high side stucco rough finish does not receive the full application of paint unless back rolled. See representative photos and review exterior paint for completeness and service as needed. The only thing cosmetic about paint is the color. Paint is a sealant that is the first and best line of defense against moisture intrusion. The paint should be serviced to be complete and to industry standards.

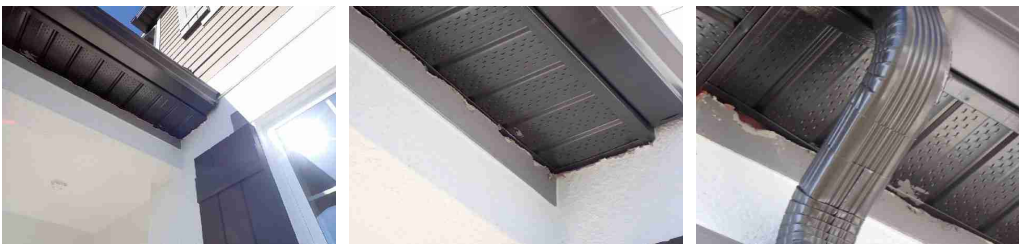
Stucco and paint surfaces have been chiseled to install soffits at front porch. Service chipped stucco and verify paint coverage is full and complete.

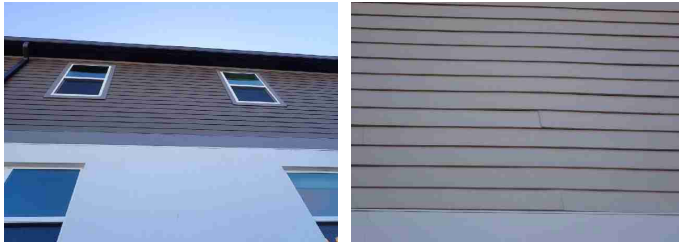
Second floor clapboard siding is not secure in areas - Fasten as needed to be complete.

Second floor clapboard siding is not secure in areas - *Continued*

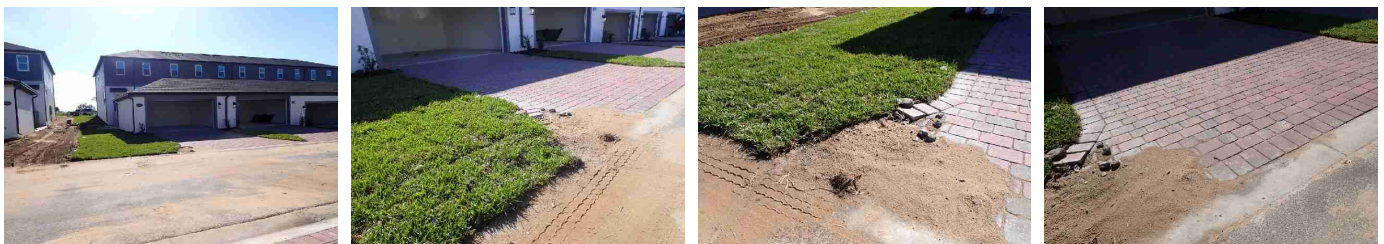
The driveway is serviceable however pavers are damaged in areas (chipped and stained with construction debris) - Service/replace sections as needed. It was noted too that at the NW corner of the driveway (at connection to alley drive) there is damaged/displaced pavers with evidence of ponding. Repair area and confirm adequate drainage for better driveway performance.

The driveway is in acceptable condition - *Continued*

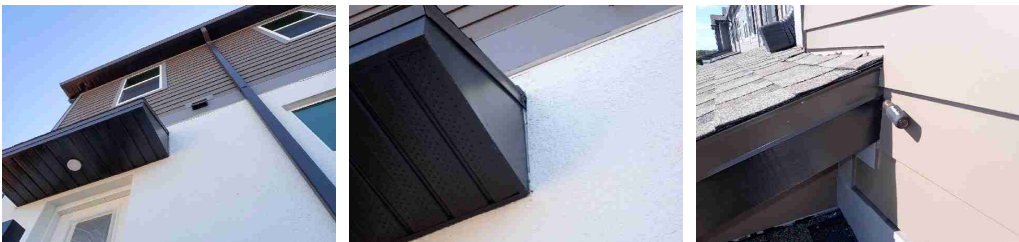
Fascia wrap at tie-backs are not sealed at sidewalls allowing moisture into the substrate. Caulk/seal/paint to protect from water intrusion damage. See representative photos.

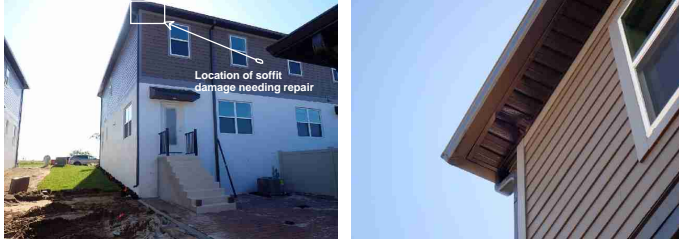
Soffits and eave vents are in acceptable condition but there is a damaged section at the second floor area of the NW corner of the unit - see image for reference.

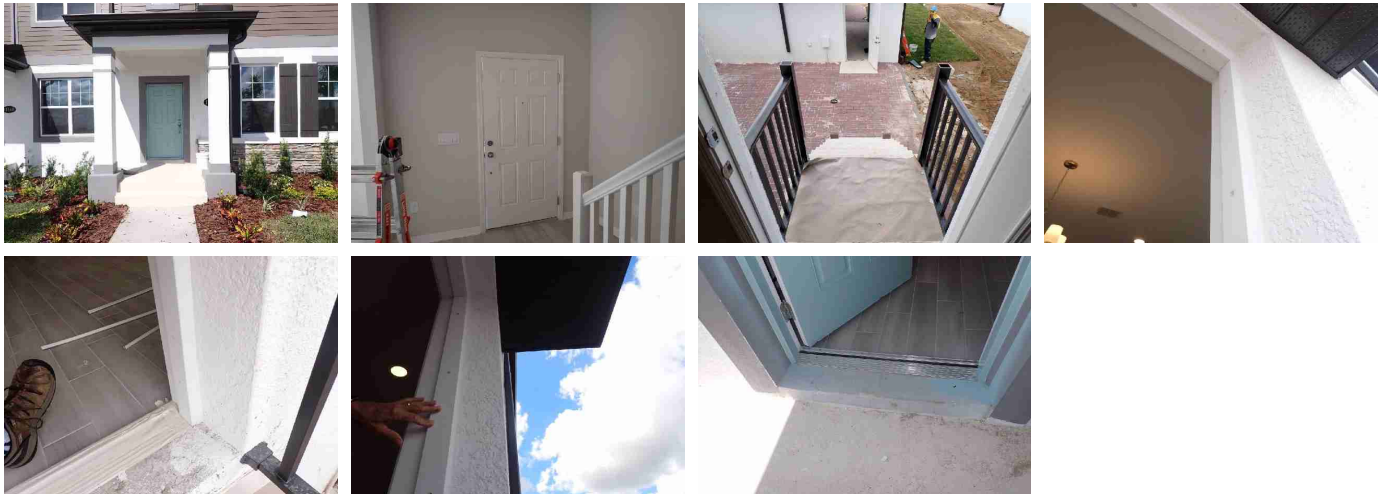
The front door as well as the rear exterior door are recessed under a covered entry foyer porch or brow. The doors are serviceable however paint of door slab frame and stucco around the door opening are incomplete. Recommend caulk/seal/paint to make installation complete.

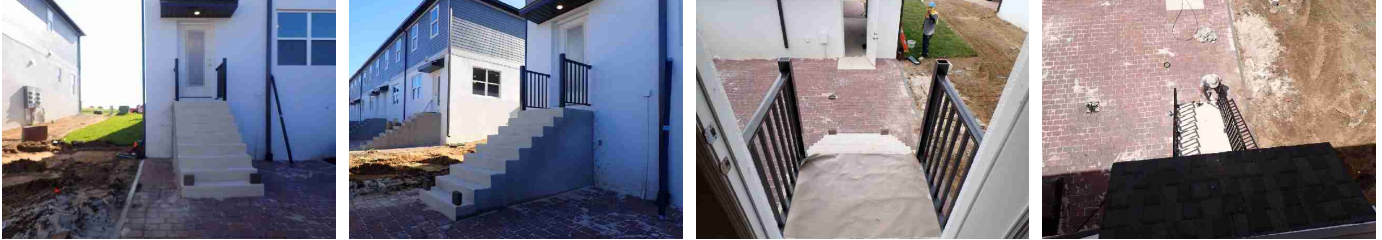
Both the front cement and rear steps are in acceptable condition. Rear stair system painting and handrail installation were in process during the time of this inspection - Verify work is complete at time of final walk through.

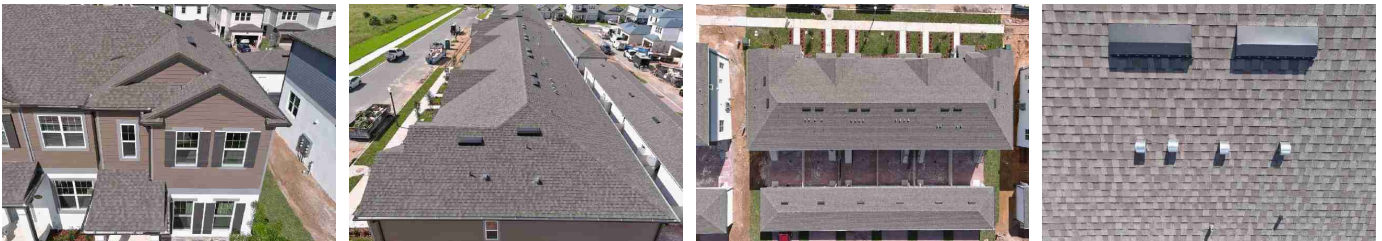
There are minor roof maintenance items that should be serviced. See below for reference. Periodic roof maintenance/review by a licensed roofing contractor is recommended.

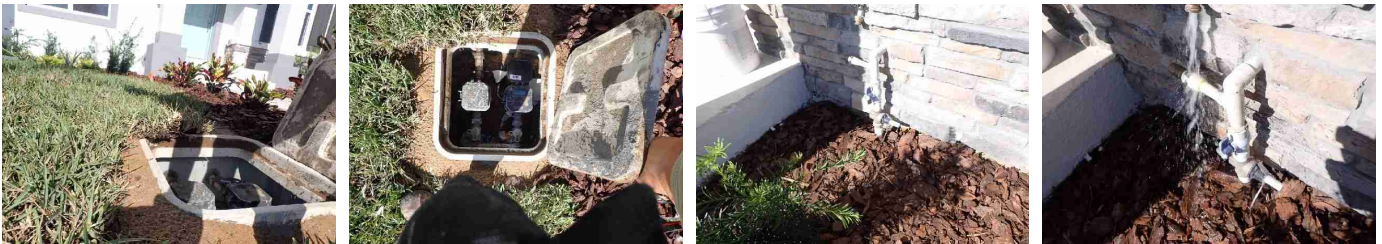
NOTE: The shutoff has exposed sections of plastic which is subject to UV and bump damage - Recommend insulate and add a bump guard to protect from damage

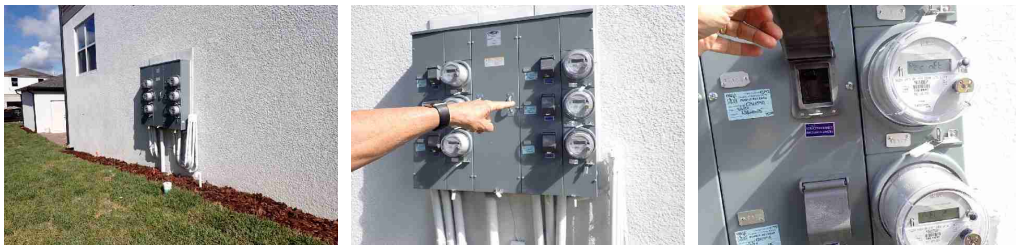
The main panel is located on the south side of the structure and is ganged together with 5 other unit meters. The main disconnect is 150 amp service. Other than determining the location of this unit main disconnect no other inspection of the main panel was performed. To do so is outside the scope of this inspection.

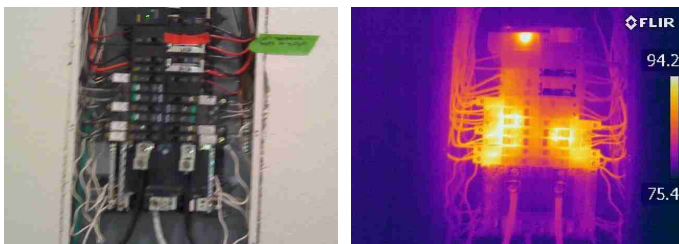
The Square D brand electrical sub panel has no visible overheating anomalies given current system loading. No overheating conditions observed with Flir T-420 infrared camera.

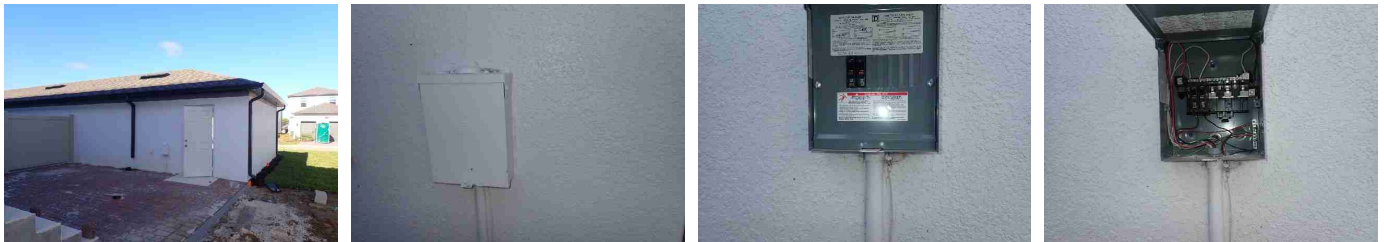
The garage sub panel is located at the exterior east wall, is a squared D brand and is in acceptable conditions.

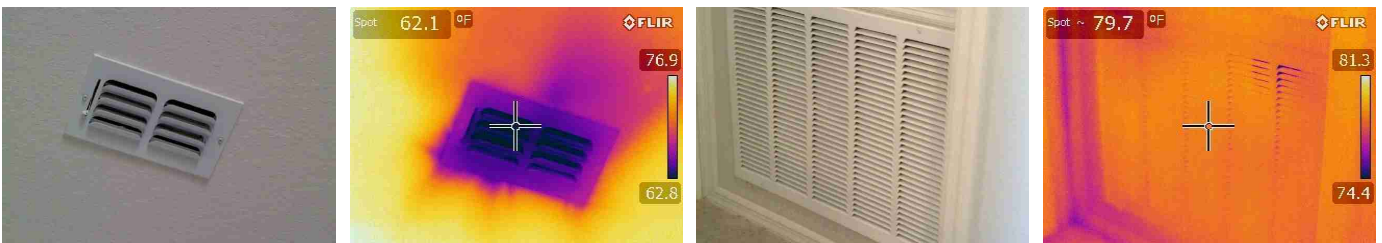
The air-conditioning responded and achieved acceptable differential temperature split between the air entering the system and that coming out, of fifteen degrees or more even with trades having the doors open during temperature sampling. Supply temperature was 62.1 degrees and return was 79.7 degrees. (17.6-Degree split)

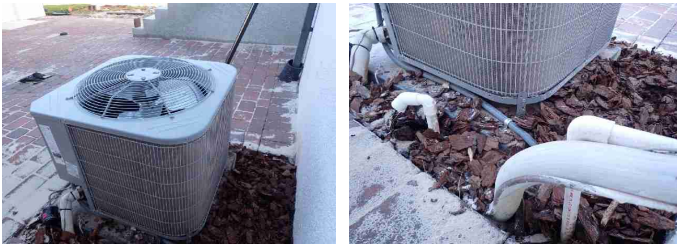
The condensing unit is mounted on a level concrete pad as is standard by today's installation requirements. A slightly elevated concrete pad assists in maintaining the condition of the units for intended useful life. The pad should not be out of level more that 10 degrees. A level unit will reduce strain on condensing fan motor bearings. The current installation is adequate. Any vegetation at near or around the unit should be kept to a minimum of 12-18 inches away to maintain adequate air flow.

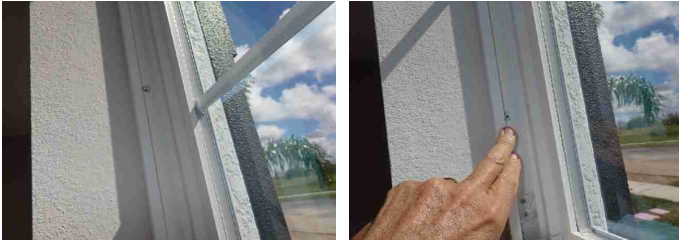
Window fastener caps are missing; cosmetic - Add/replace. See photo for reference.

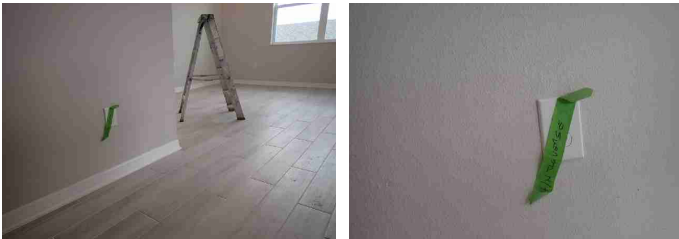
NOTE: Outlet outside laundry, as marked, on the north wall to the rear registers hot/neutral reverse - Service as needed.

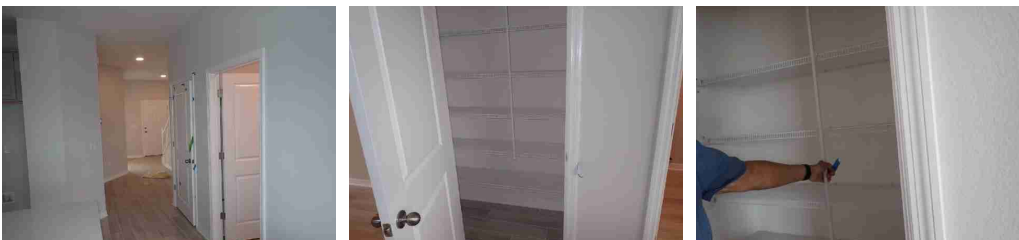
The hall pantry closet shelving support is not yet fully installed - Service as needed.

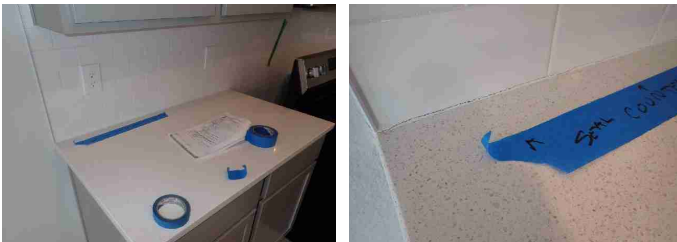
Separations between the counter top back splash are to be caulked to forestall moisture intrusion.

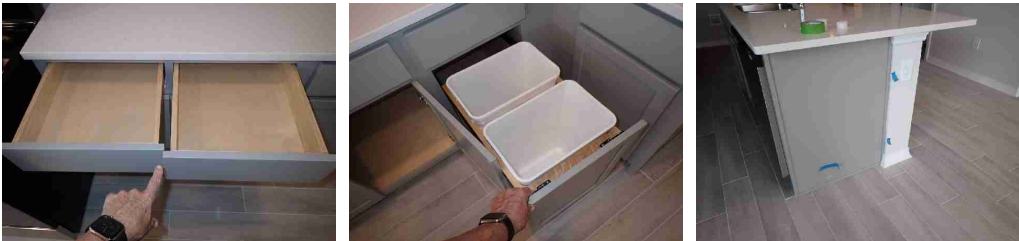
1. Recommend adjust doors/draws most noted at double drawers right of the range and the pull out cabinet for the trash bins.
 2. Cabinets end caps at island need cleaning.
 3. Fill strip is missing in areas - see cabinet attachment to the refrigerator cabinet surround for example.
- Review all areas and service as needed.

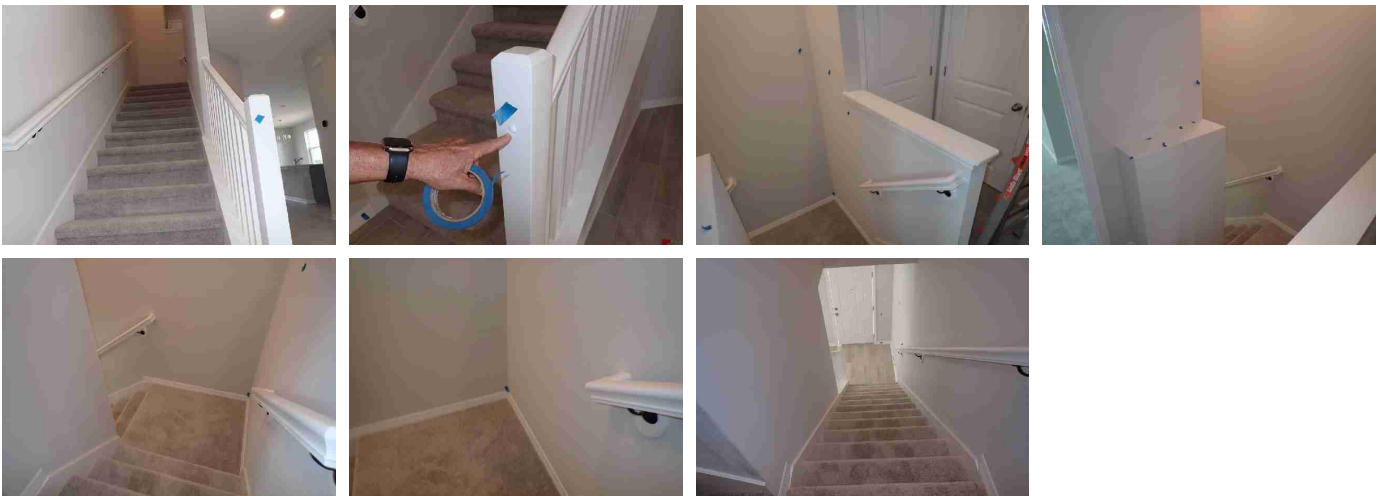
1. There is paint touch up needed as identified with blue tape
2. Staircase railing fastener cap(s) are present but appear loose - Adjust installation to be fully secured.
3. Drywall nail pop bulge at top of stair west wall needs minor service.

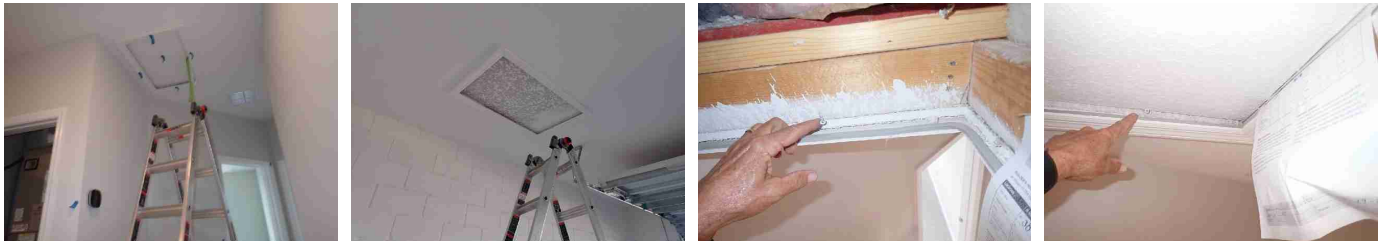
The attic can be accessed through a hatches in the hallway ceiling and in the detached garage at the rear of the unit. The framing drywall screws are to be removed to complete installation. Further the weather stripping will need adjustment to fully function as designed.

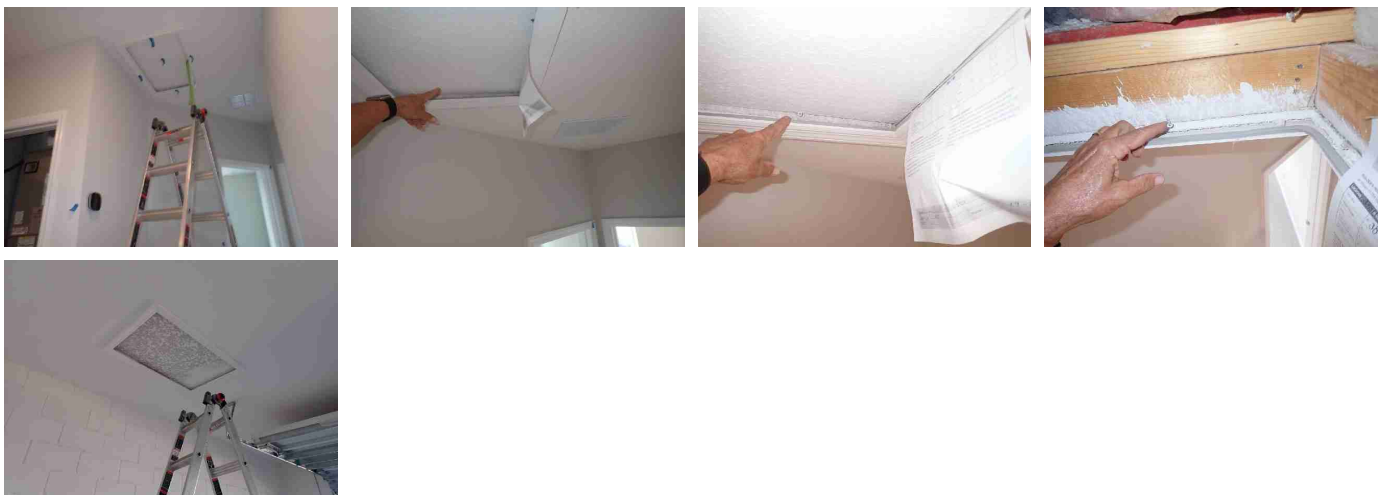
The attic access hatches are in acceptable condition but need paint of the hatch and the trim holding the hatch. The living area panel is cracked at the consider replacing the panel with new. The framing drywall screws are to be removed to complete installation. Further the weather stripping will need adjustment to fully function as designed.

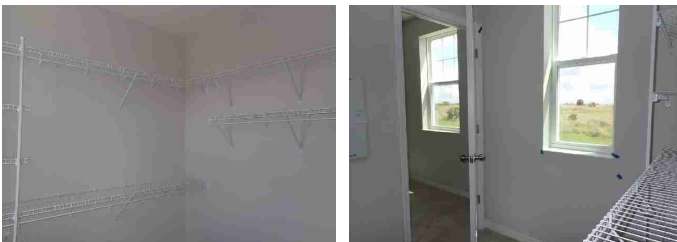
The closet(s) and its components are functional but need paint touch up.

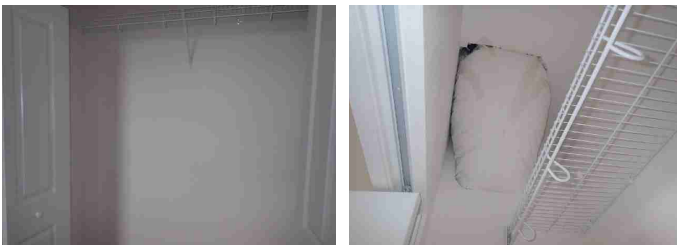
The general condition of this first guest bedroom is consistent with the master bedroom, in addition, the duct to drywall needs to be sealed in the closet

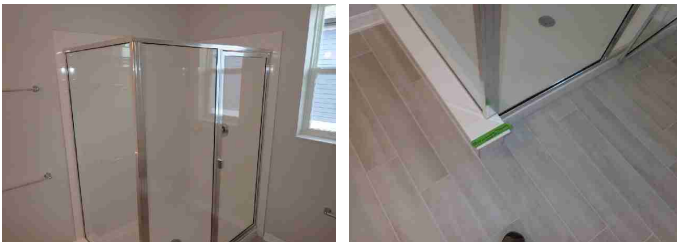
Shower curb sill that the glass wall assembly is mounted has sharp corners. Recommend rounding edge of the sill material - see image for reference.

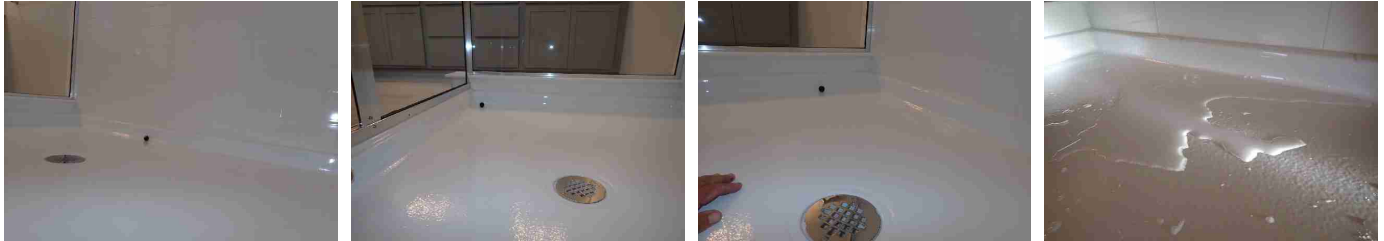
Recommend reset the shower pan for better drainage and standard safety protocol.

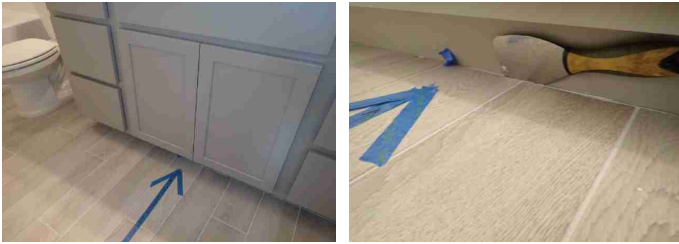
The floor tiles have been laid to the cabinets instead of under them - *Continued*

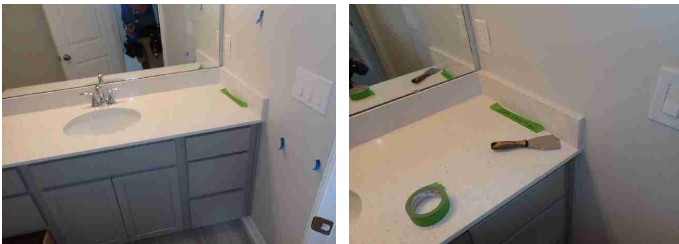
There is a typical separation between the sink countertop and the back-splash, which should be re-sealed to forestall moisture intrusion between the cabinet and the wall.

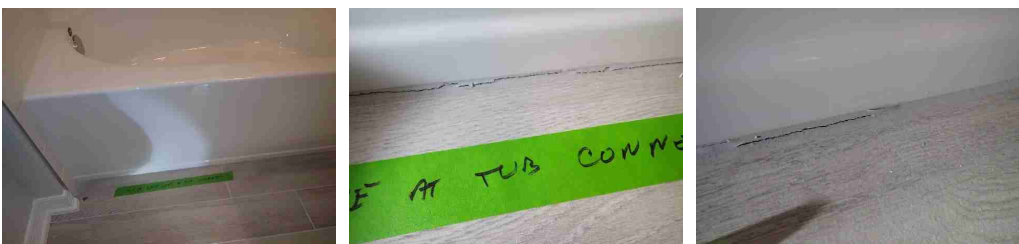
In an effort to forestall moisture in the sub-floor the tub edge where it meets the tile floor needs to be sealed.

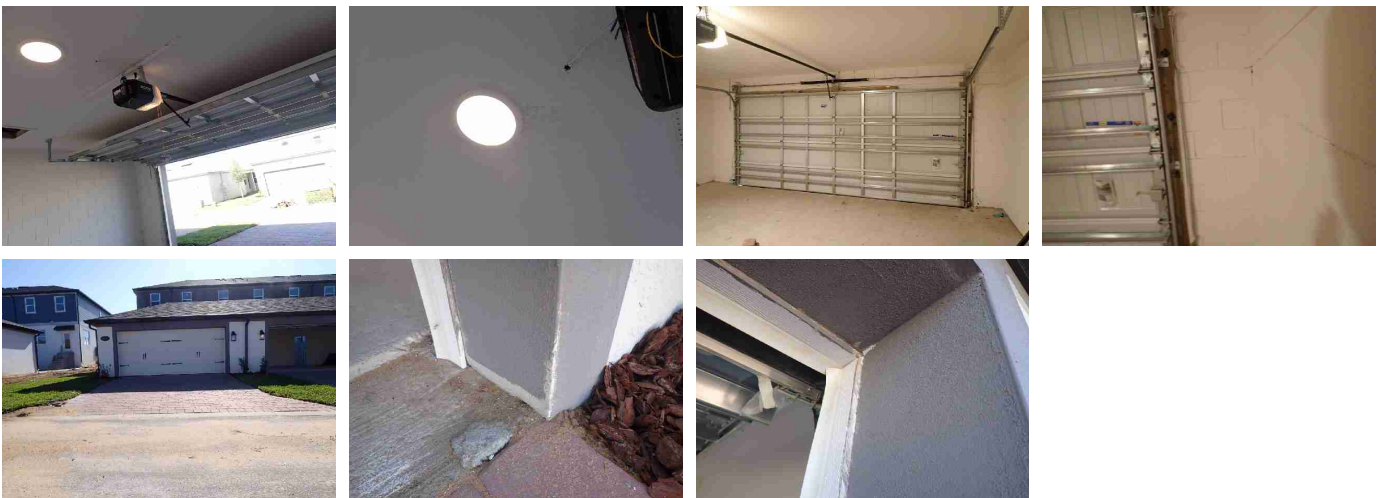
The exposed visible walls are in acceptable condition but paint is incomplete at various grout lines, walls connection to the floor and at areas around the overhead door openings plus buck boards.

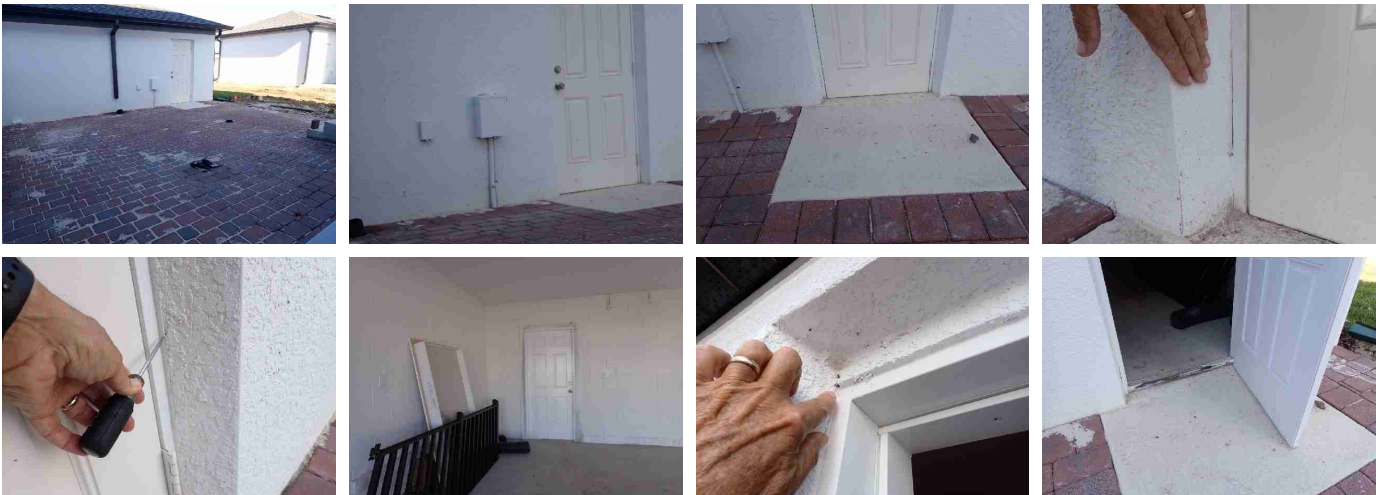
1. Door paint and sealant system of the door slab, door frame and surrounding stucco is incomplete - Service as needed
2. This door is at grade and therefore water damage conditions exist. It is critical to keep the door system sealed to reduce the risk of moisture intrusion and subsequent damages.
