# Signature Inspection Services

## CONFIDENTIAL INSPECTION REPORT

**Sample New Construction Home Inspection**

Sample, Ovideo, FL 32765

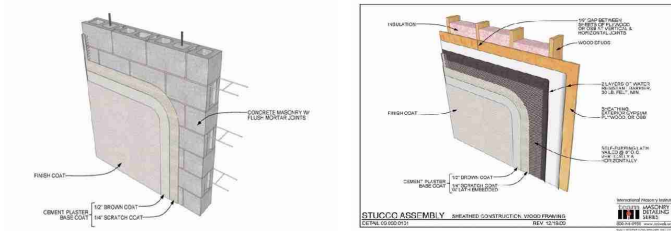
The house walls are finished with stucco.

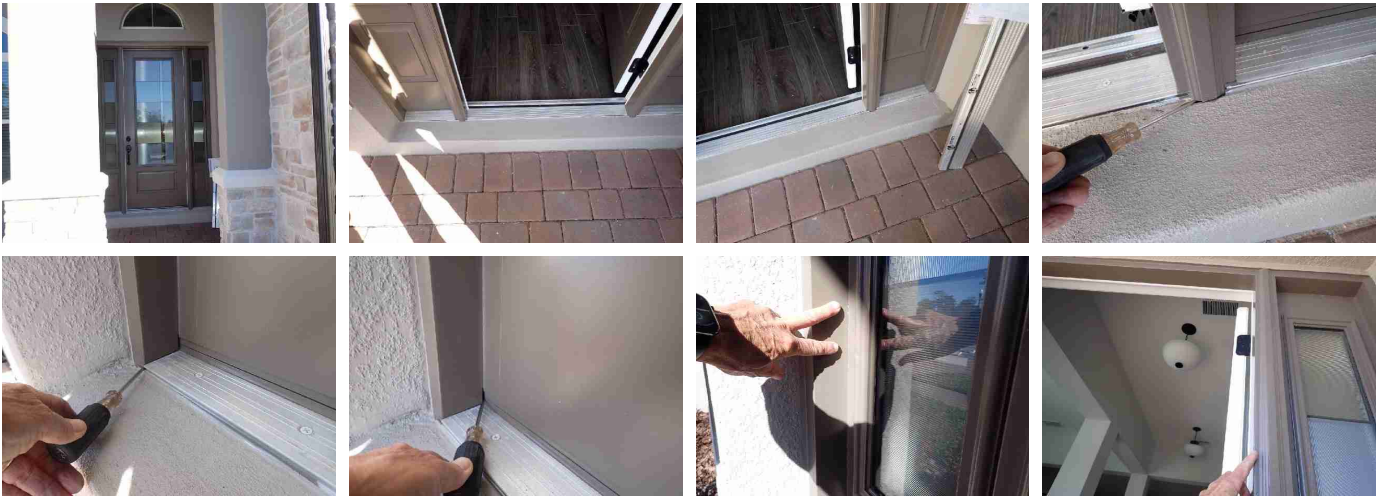
1. The base of the door wood frame is gapped at connection to the door seal.
2. There is minor paint touch up needed of the door slab and frame.

3. As in any home purchase it is recommended that the locks be changed for added protection from previous occupants no longer granted access.

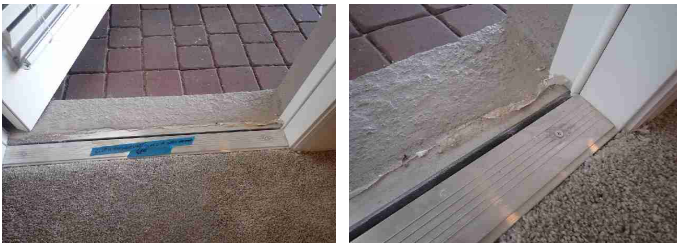
The master bedroom door to exterior needs service at stucco connection to the door sill frame plus overall cleaning of construction type debris and splash.

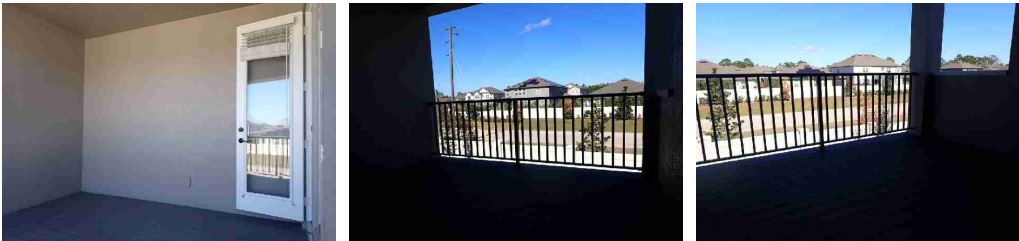
The balcony, or balconies, is in acceptable condition.

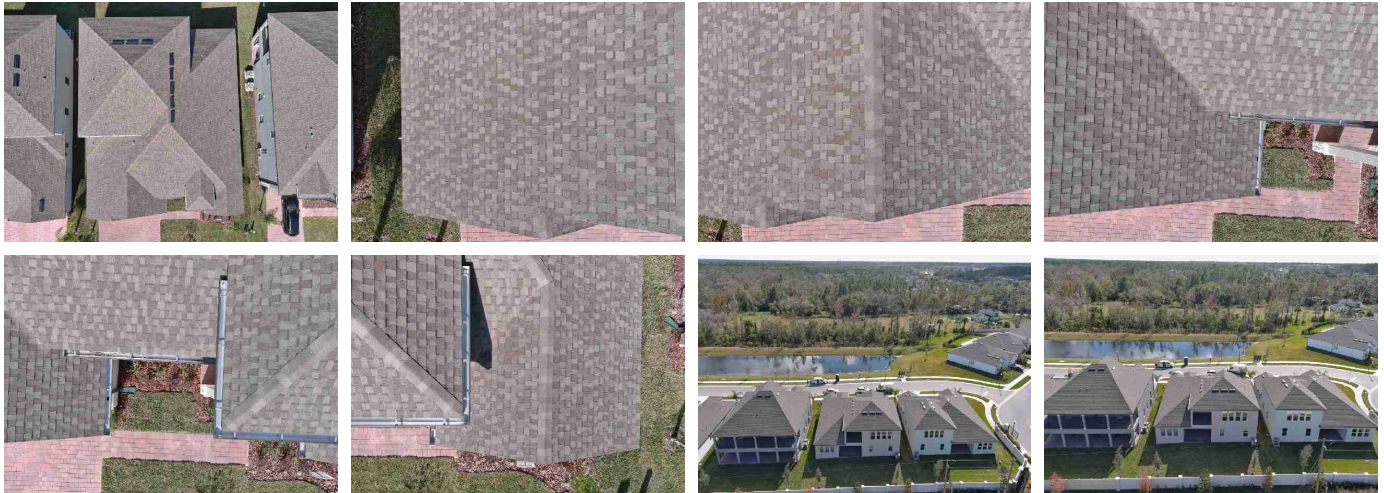
The roof is new. Anticipated useful life expectancy, with periodic service/maintenance, is 20 +/- years.

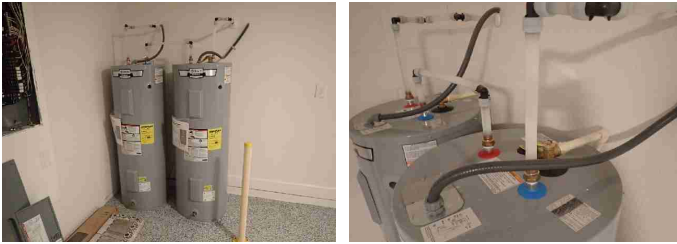
The water pipe connections to the electrical water heater are functional and includes a shutoff as recommended.

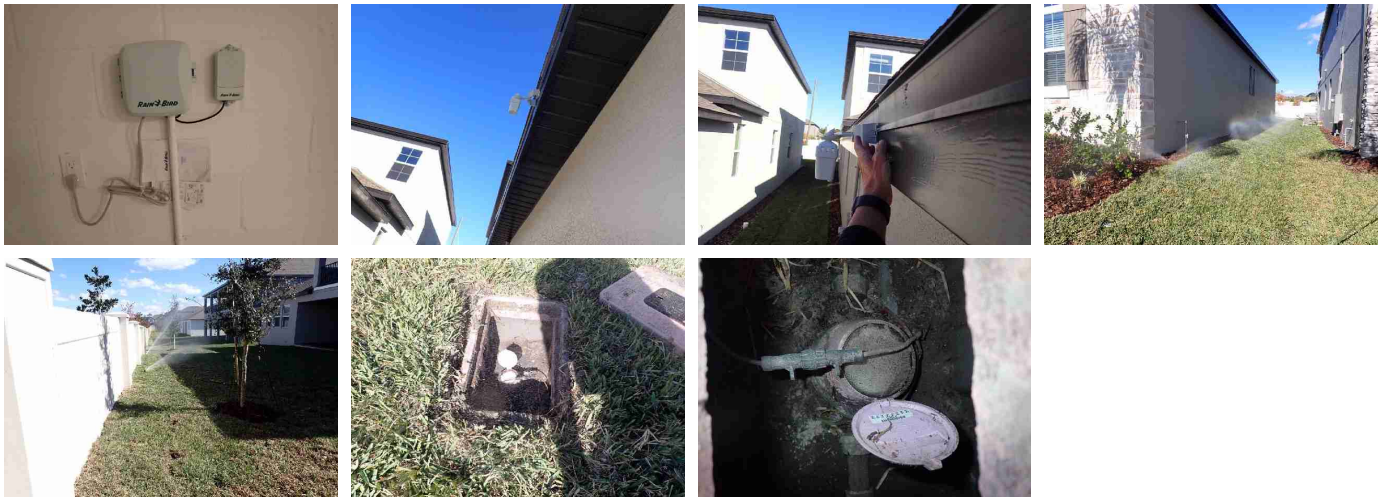
There is a rain gauge install on the left side into the fascia. The installation is not secure and therefore considered incomplete - service as needed

As a general rule and for all irrigation system recommend trimming vegetation, adjusting, and clearing heads for better and more complete coverage. In addition tall risers, if applicable, should be supported by something other than the PVC pipe itself. Sprinkler heads near the home should be adjusted so as to not spray on the home nor on walkways and driveway. Municipalities have certain watering restrictions which you should become familiar. Recommend periodic review by an irrigation specialist.

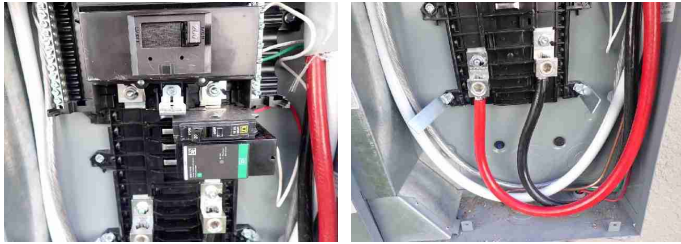
However wire pigtails stripped of the non-metallic sheathing are nicked in areas which creates added resistance to the power flow. Recommend electrician review all wire stripping and determine cable condition is within common standards.

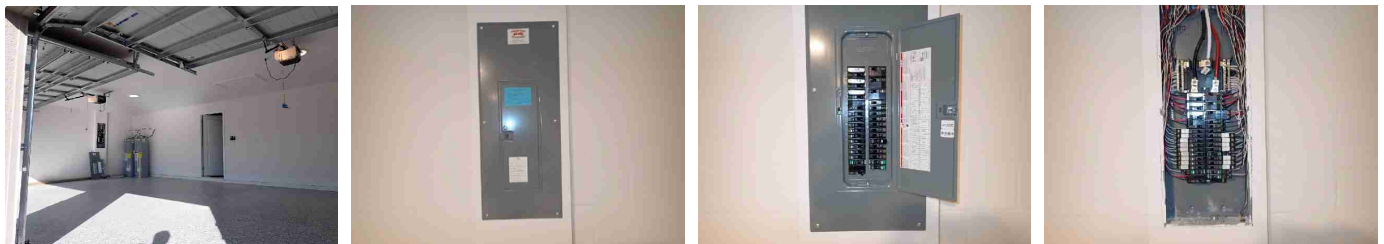
The sub panel is located in the garage.

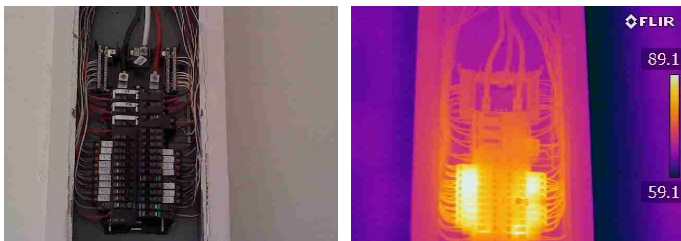
The Square D brand electrical sub panel has no visible overheating anomalies given current system loading. No overheating conditions observed with Flir T-420 infrared camera.

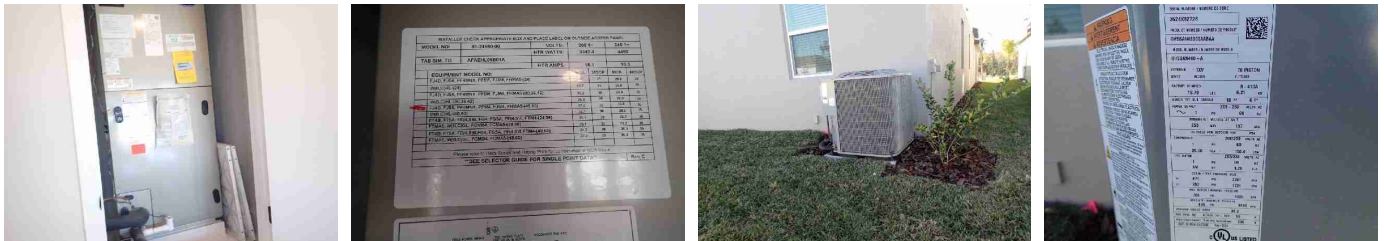
Central Heat and AC are provided by a heat pump system with a new, 5-ton air handler located in the up bonus room closet and a condensing unit that is also new and 5-ton located on the NW corner of the home. The system sized by age and rule-of-thumb standards as compared to the square footage to be adequate for this installation.

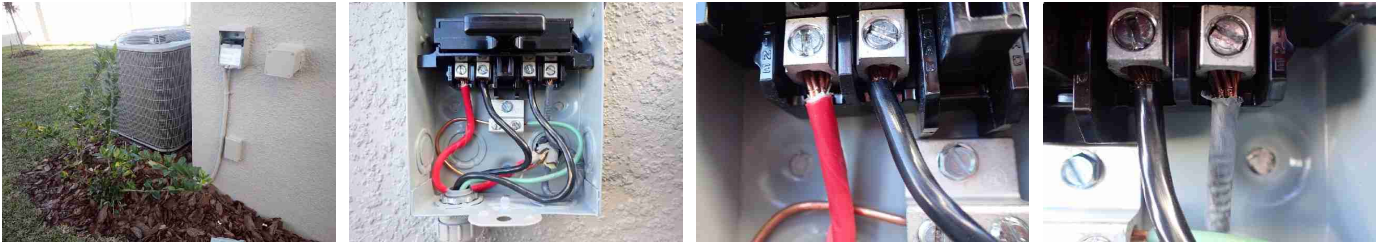
There is an electrical disconnect at the condensing coils as required. The over current protection is located in the panel in the garage 50-amps with max appliance rating of 50-amps which is within acceptable range. Minimum conductor ampacity is 33.2-amps and conductor size is 8-gauge which is also within range. NOTE: Cable stripping has damaged conductors - Recommend licensed electrician review installation as service as needed to meet common professional standards. Nicked conductors increases resistance.

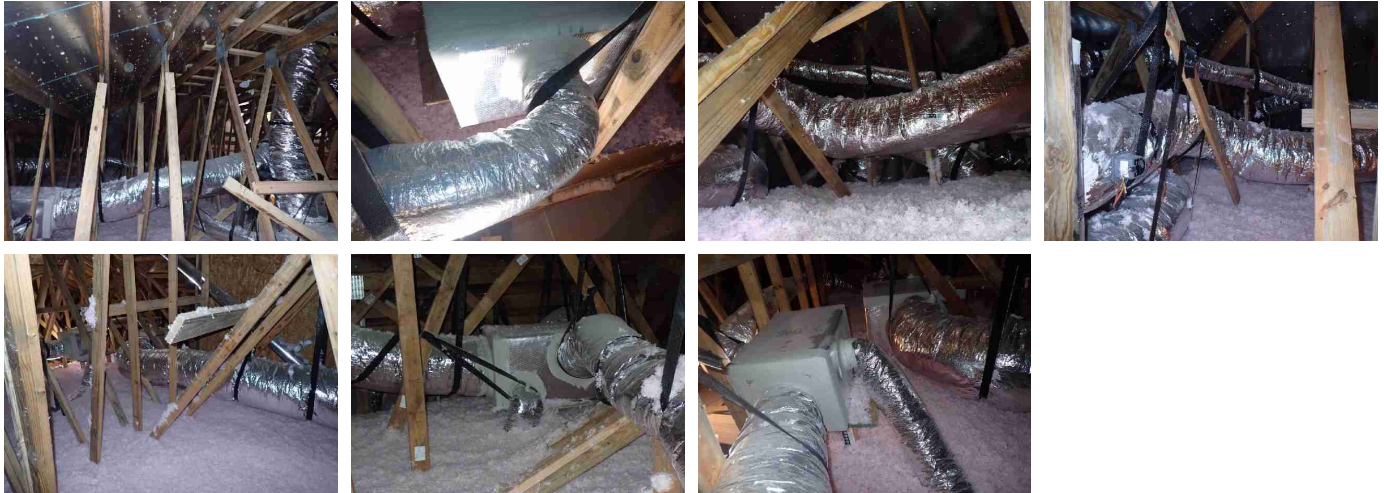
They are a modern flexible type that are comprised of an outer plastic sleeve and a clear inner liner that contains fiberglass insulation. The ducts have no visible deficiencies however there some sharp turns in trunk lines that crimps the duct and reduces air flow. Periodic review and adjustment (added support) of flexible ductwork is recommended. Flexible ductwork does tend to sag over time thus restricting air flow and system efficiency.

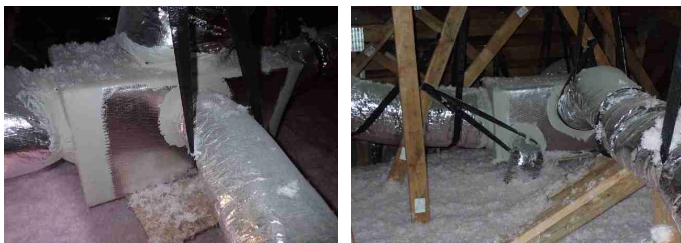
The duct distribution chambers are a semi-rigid compressed fiberglass type that can be easily damaged and do not spring back into shape. Also, their fibers could provoke an allergic response in people sensitive to this material. The fiberglass distribution ductwork visible in the attic was found to be in acceptable condition.

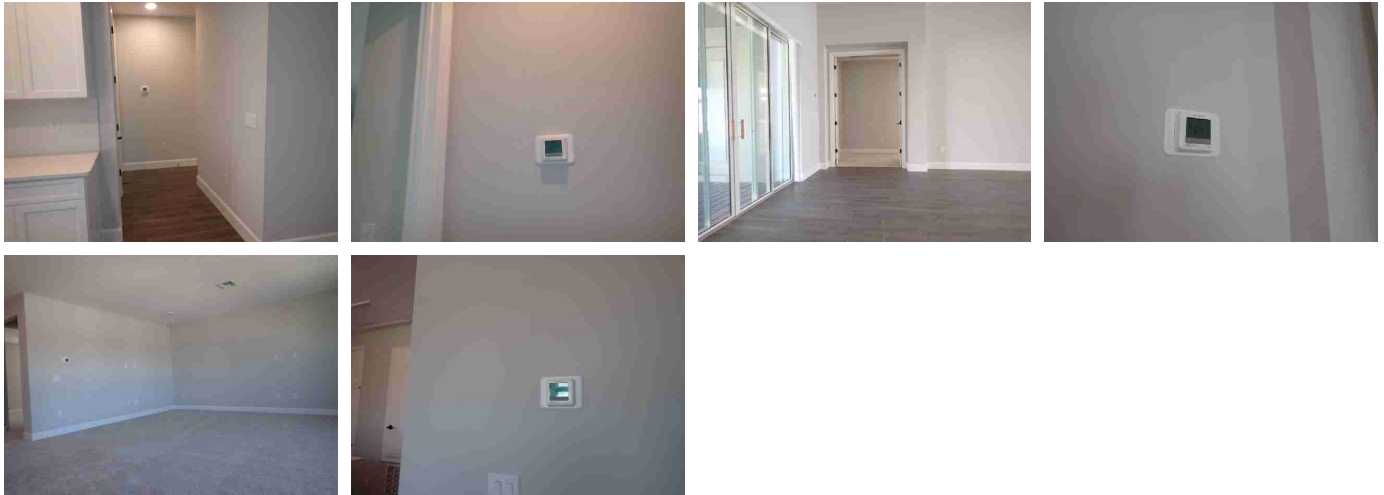
The Thermostats are in acceptable condition.

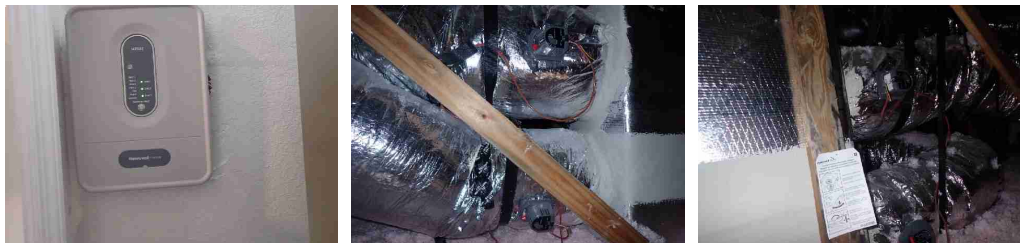
The ducts include thermostatically controlled dampers, (3-each) which are concealed and therefore cannot be evaluated as part of our service. However a representative number of supply register temperatures were taken during operation of the system and no abnormal temperatures were observed. There are three zones, right side down stairs, left side bedrooms hall and bath and up bonus room bedroom, bath and bar kitchen.

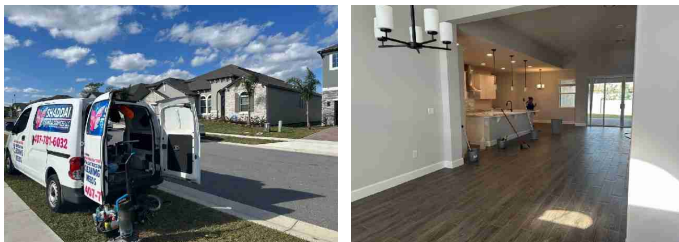
The floors in the living areas are carpet, and tile. Both are in acceptable conditions. Tile final cleaning was in process during that latter portion of this inspection. The Staircase flooring is a composite which is also in good condition but needs final cleaning.

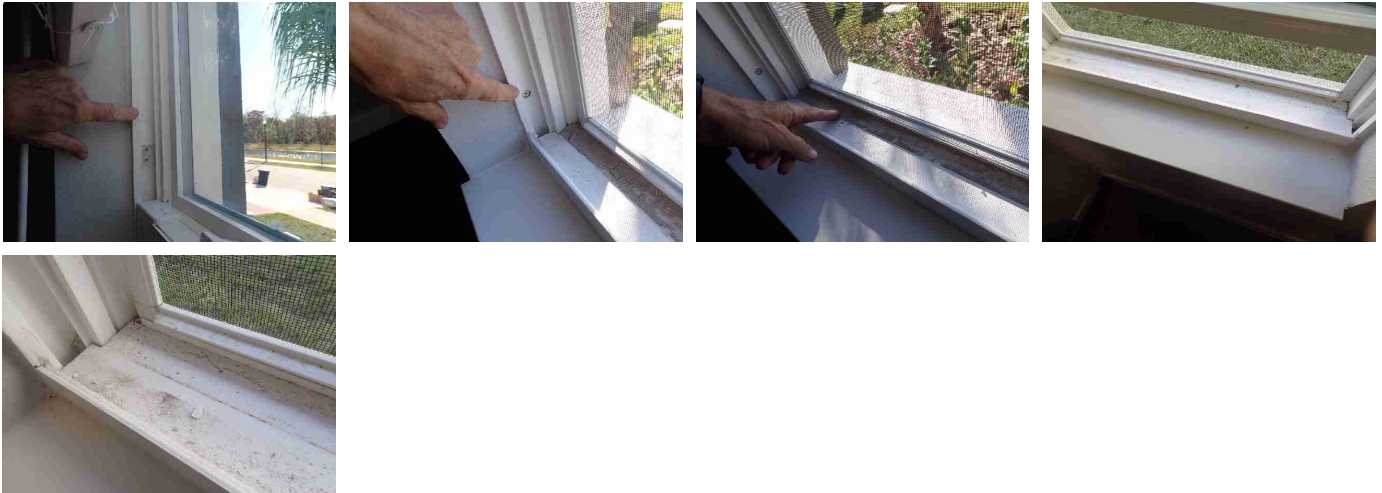
1. The first floor window frame rail fastener caps are not installed at lower sash areas - Cosmetic, service as needed to meet common manufacturer standards
2. When lifting window sashes it is noted that all window sills need cleaning of construction dust and debris - service as needed to be new and clean.

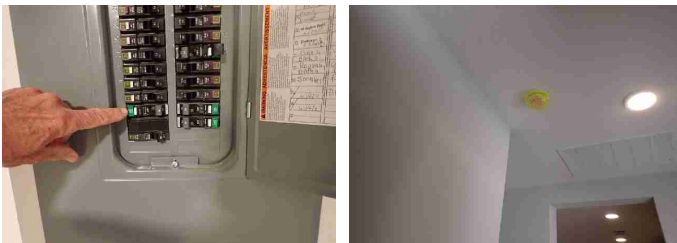
The smoke detector system is present but needs service so as to operate as intended.

1. All units are covered with plastic bonnets to protect from damage during construction processes - Recommend remove when home is readied for occupancy.
2. The breaker for the smoke detector system dedicated power supply is flashing yellow suggesting the need for service.
3. Various smoke detector units are "chirping" suggesting then need for battery update replacement Service system fully as needed now and certainly prior to occupancy. Smoke detectors should be checked regularly by depressing the test button on each and changing battery backups as customarily recommend twice yearly.

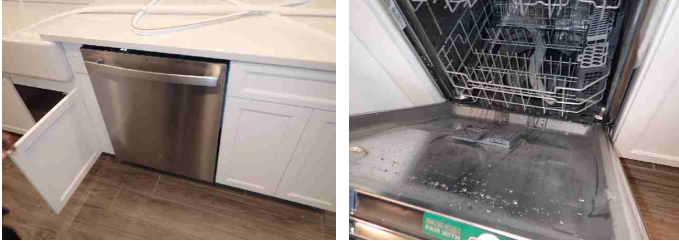
The dish washer was recently operated and therefore considered functional at the time of this inspection and includes the recommended high loop drain feature. Recommend that the builder re operate these appliances to your satisfaction during new homeowner orientation.

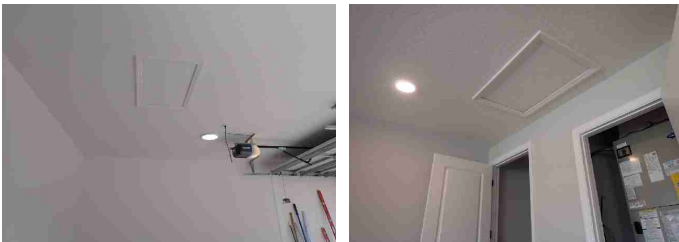
The attic can be accessed through a ceiling access panel in the garage and a ceiling panel in the up bonus room bar sink area.

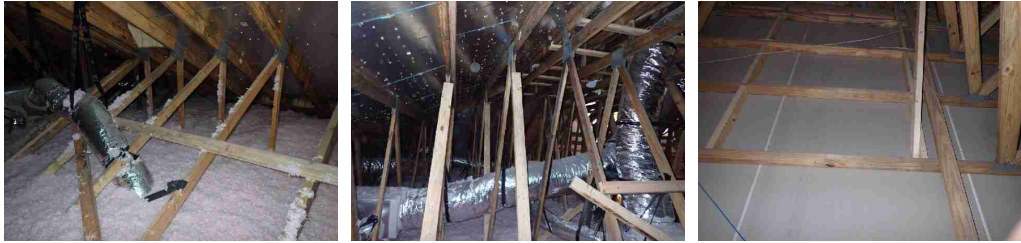
The roof decking consists of O-S-B decking and the framing consists of a factor-built truss system, comprised of components called chords, webs, and struts that are connected by wood or metal gussets nailed or glued in place. OSB chip separation noted but not structure issues observed. Each component of the truss is designed for a specific purpose, and cannot be removed or modified without compromising the integrity of the entire truss. The lowest component, which is called the chord and to which the ceiling is attached, can move by thermal expansion and contraction and cause creaking sounds, which are more pronounced in the mornings and evenings along with temperature changes. Such movement has no structural significance, but can result in small cracks or divots in the drywall or plaster.

Foil backed OSB roof decking is damaged in areas - Recommend full review of both attic areas and service/repair damaged foil areas for full design benefit of this radiant barrier. see photos of examples

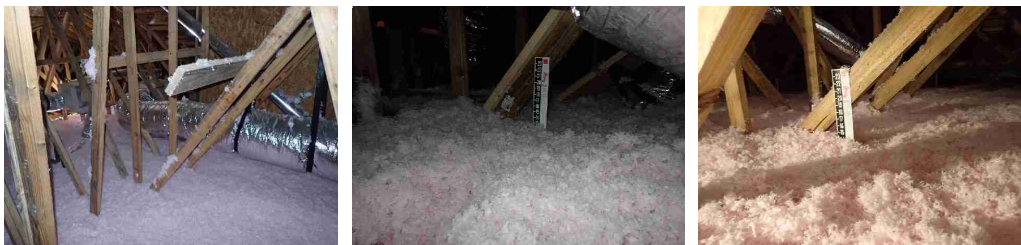
The attic is insulated, with approximately 15+/- inches of blown-in fiberglass insulation that is overall in acceptable condition.

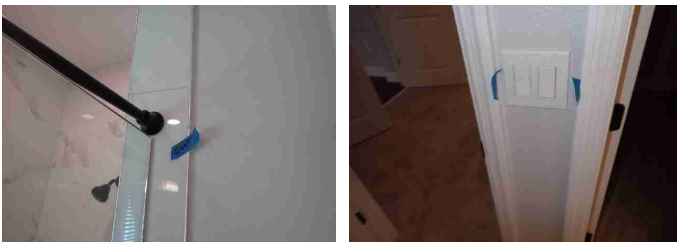
The walls and ceiling are in acceptable condition other than paint touch up. Marked areas are in blue tape.

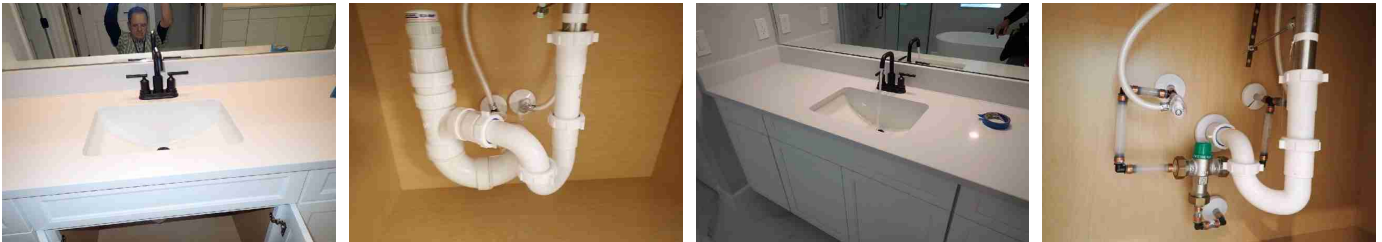
The sinks and components are functional.

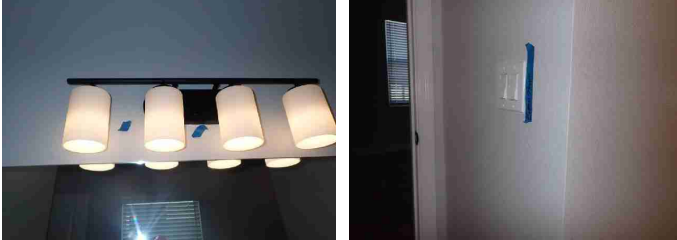
The walls and ceiling are in acceptable condition but need touch ups as identified with blue tape - Service as needed to be complete.

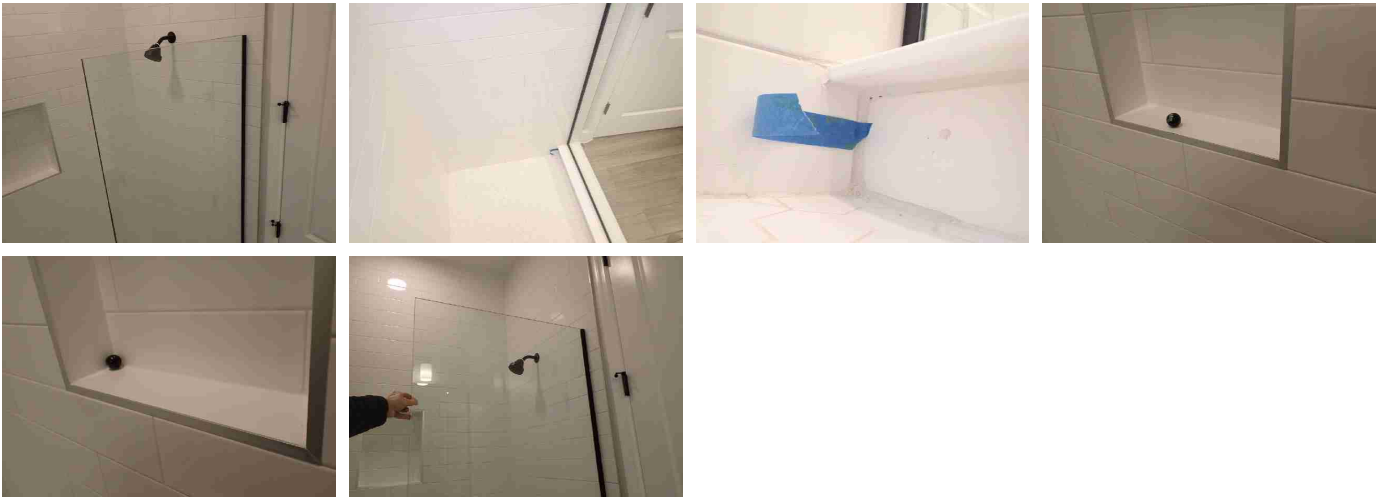
1. Minor caulk/grout needed at glass frame to tile connections and at shower curb cap to shower floor perimeter - Address as needed to protect from moisture intrusion to within the substrate and subsequent

damage with time.

2. The wall inset shelf for sundries is level an/or negative pitched with a bull nose installed higher than the tile shelf leading edge. As a result drainage is restricted and water area ponds on the shelf over time stressing the tile system. Recommend reset tile and metal bull nose trim to adequately drain shower spray buildup.

3. The water pressure at this shower head is low compared to other faucets in the home. Recommend builder review and service as needed for better flow.

NOTE: Use caution at the shower system stationary glass wall as it is supported on two only and therefore subject to bump damage.

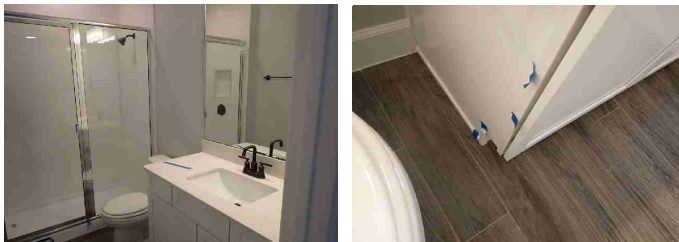
The cabinets are in acceptable condition but missing pulls. In addition the left side of the cabinet has exposed fasteners and the filler trim is gapped - Repair fasteners and paint/seal areas of cabinet as needed.

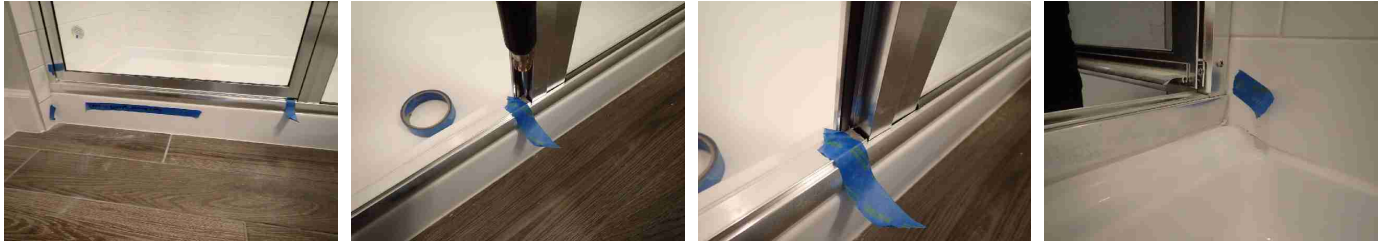
The stall shower tile was serviced by trades during the inspection and therefore the shower was not operated for concern of damaging that not yet cured service. See builder for operation verification during new homeowner orientation.

In addition, the glass frame wall and door system needs sealant at various connections - Service as needed to meet manufacturer installation specifications.

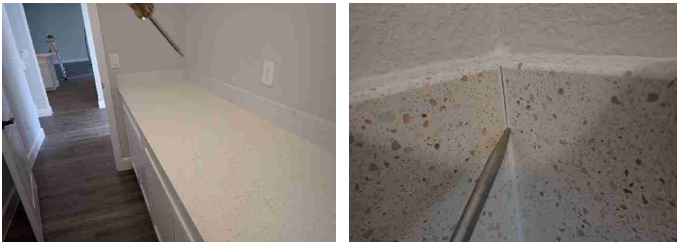
There is a typical separation between the sink back and side-splash in the corner and at the drywall, which should be sealed.

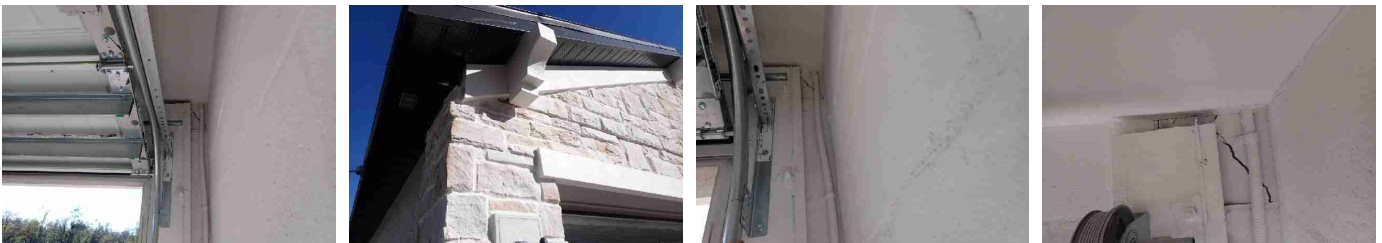
At the right front corner (SW) above the double overhead door opening there is a stress cracked block. There appears to be no other deficiencies around it or on the exterior. Recommend review with your builder, service as needed and at the very least monitor. See photos for reference.

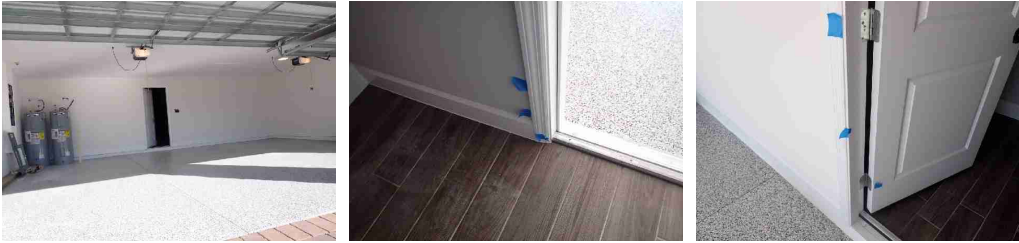
The house entry door is solid core, or fire-rated, and is in conformance with fire-safety regulations for the time it was constructed. However the door does have minor service of cosmetic damage and paint touch up - Service as needed to be complete. Further the door gasket system is not yet installed and will need to be prior to occupancy.

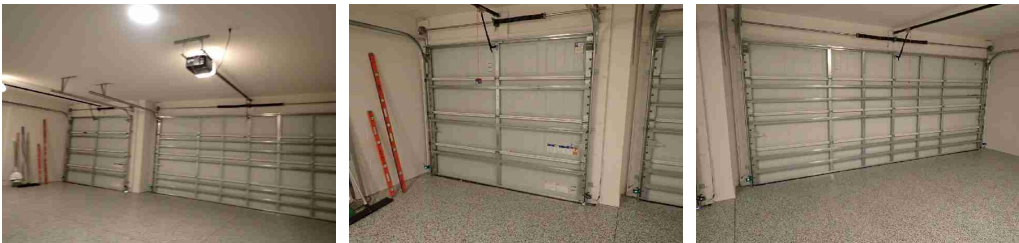
The garage doors and hardware are functional. They are single and double torsion counter balance systems. Buck boards are secure. There are limited horizontal bracing and no vertical bracing as per wind borne debris region specifications. Therefore, for this and other issues noted these are not hurricane rated doors that are often seen in coastal and south Florida regions. Upgrade as you see fit or as insurance premiums may suggest.
