CONFIDENTIAL INSPECTION REPORT

Sample Townhome Inspection Report

Sample, Winter Garden, FL 34787

9/3/2024 9:00 am to 12:30 pm

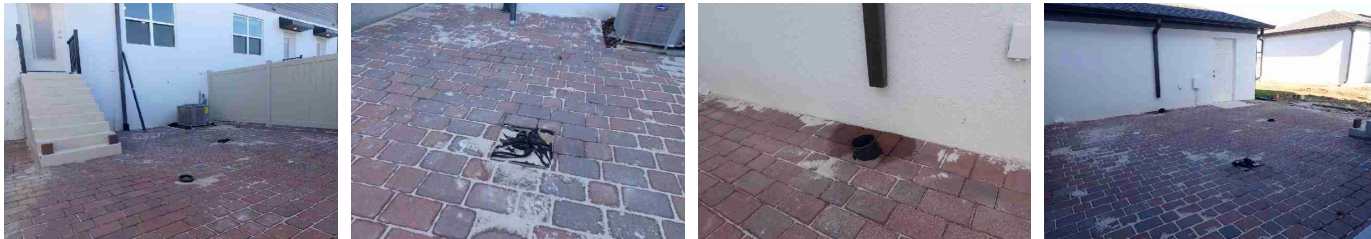
The property is served by area drains (center rear paver patio deck) that appear to be in acceptable condition. However, because it is impossible to see inside them, the seller or municipality should guarantee that the drains are functional, or they should be flushed before the close of escrow. Surface water carries minerals and silt that when deposited inside the pipes can impede drainage and require the pipes to be cleared by a roter service.

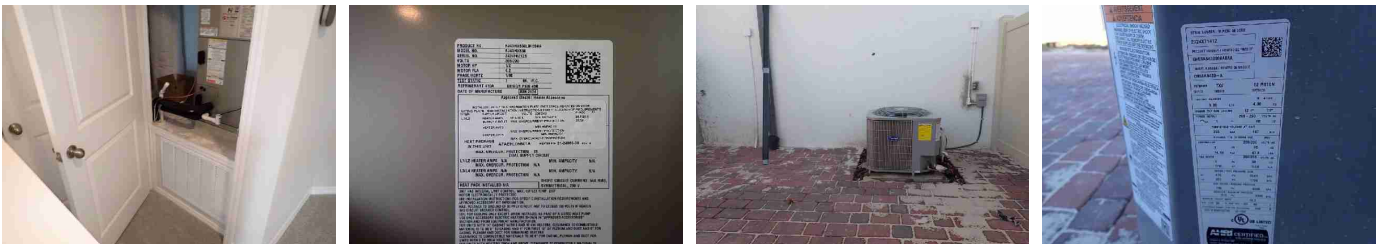
Central Heat and AC are provided by a heat pump system with a new 2.5-ton air handler located in the up hall closet and a condensing unit that is also new and 2.5-ton on the west side of the unit. The system sized by age and rule-of-thumb standards as compared to the square footage to be adequate for this installation.

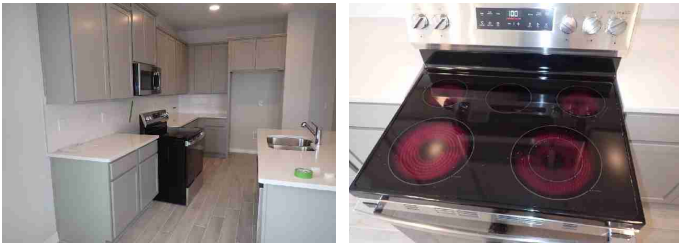
The electric range is functional in the oven, broiler, range top setting. The appliance installation includes the recommended anti-tip device. The range was neither calibrated nor tested for its performance.

Drywall at range outlet is damaged/incomplete - Service as needed.

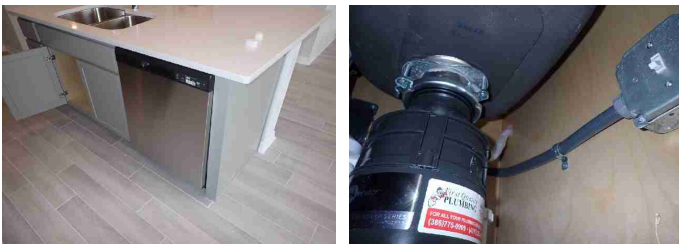
The dishwasher is functional (based on builder recent operation complete shortly after onsite arrival) and includes a mandated anti-siphon valve or air gap (using a high loop method.)

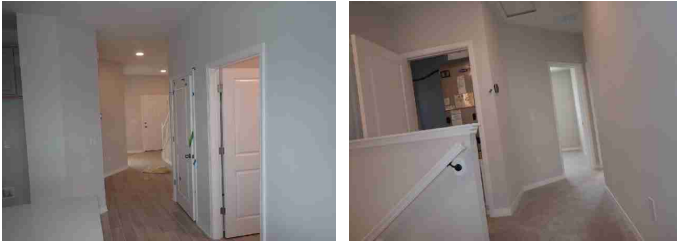
We have evaluated the hallways and found them to be in acceptable condition, including operational 3-way hallway light systems.

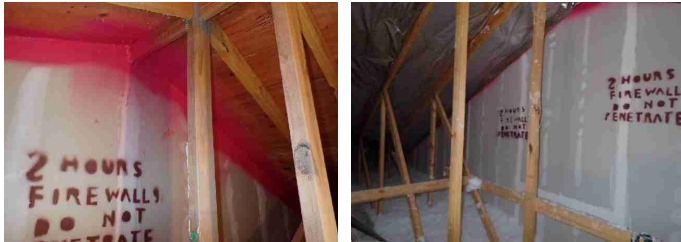
The fire stop sheathing between the adjoining units is complete and to standards.

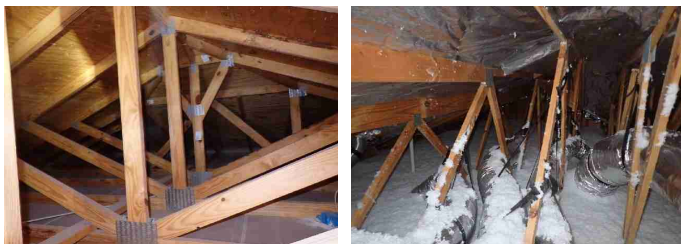
The roof decking consists of plywood decking and the framing consists of a factor- built truss system, comprised of components called chords, webs, and struts that are connected by wood or metal gussets nailed or glued in place. Plywood chip separation noted but not structure issues observed. Each component of the truss is designed for a specific purpose, and cannot be removed or modified without compromising the integrity of the entire truss. The lowest component, which is called the chord and to which the ceiling is attached, can move by thermal expansion and contraction and cause creaking sounds, which are more pronounced in the mornings and evenings along with temperature changes. Such movement has no structural significance, but can result in small cracks or divots in the drywall or plaster.

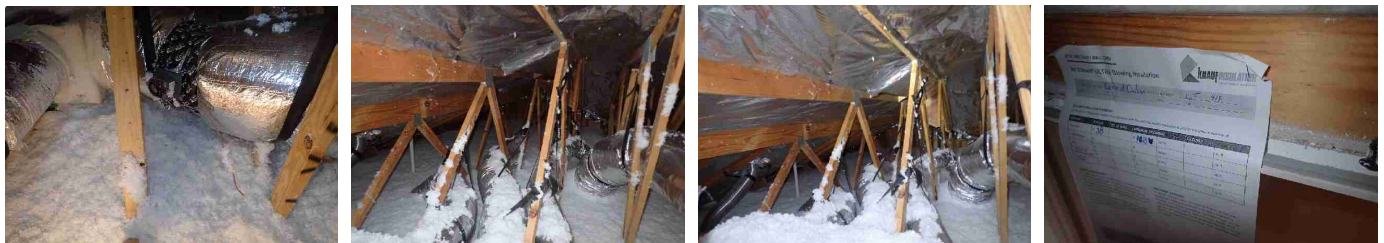
The attic is insulated, with approximately three to 12-inches of blown-in insulation which appears adequate and standard. In addition there is radiant barrier on the under side of the truss top cord.
